SAFETY ALERT

Flight bar ejects - hitting worker while installing a conveyor chain

CM9 reference	DOC19/603537
Mine safety reference	SA19-03
Date published	5 August 2019
Authorised by	Chief Inspector Office of the Chief Inspector

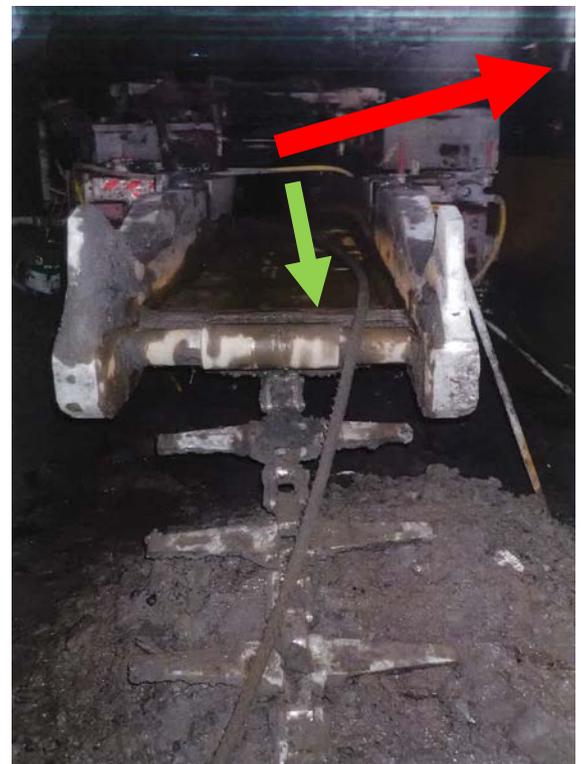
One side of the flight bar failed and was ejected from the tensioned sling towards the worker who was standing near the rib bolter controls on the right hand side of the continuous miner.

Figure 1 The red arrow shows the trajectory of the broken flight bar. The green arrow shows the pull direction of the 22 millimetre rope pulling the conveyor chain around the sprocket underneath the head of the miner.
