Fatality involving an articulated dump truck

Mines safety alert no. 358

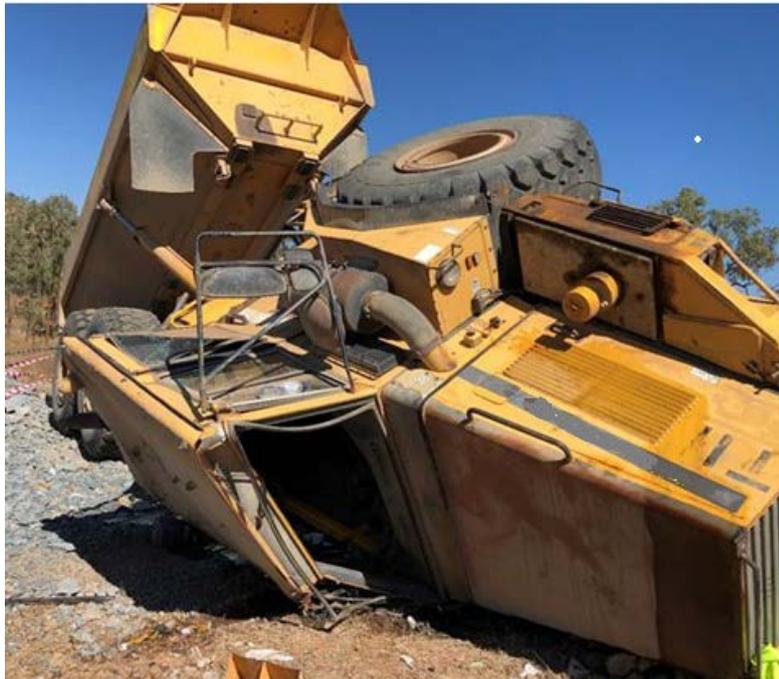
On Sunday 29 July the operator of an articulated dump truck was working at a quarry with his last load of the day. Moving fully loaded down the access ramp, it appears he lost control of the vehicle. At the bottom of the ramp the vehicle overturned (see photo), partially pinning the operator under the cab. He later succumbed to his injuries.

- Site senior executives must ensure machines are operated with reference to original equipment manufacturer (OEM) specifications.
- Site safety and health management systems must include safety requirements as stipulated by the OEM with respect to the use and maintenance of safety critical items.
- Site senior executives must ensure that all equipment on site is suitably maintained and serviced in accordance with OEM requirements and site specific hazards. Service and operational manuals for equipment must be available on site.
- Site senior executives must ensure all workers are competent to perform tasks on site and are competent on the particular equipment being operated. A record of the training must be maintained to show that workers possess the relevant competencies.
