# Miner struck by rockfall at development face

## Mines safety bulletin no. 173

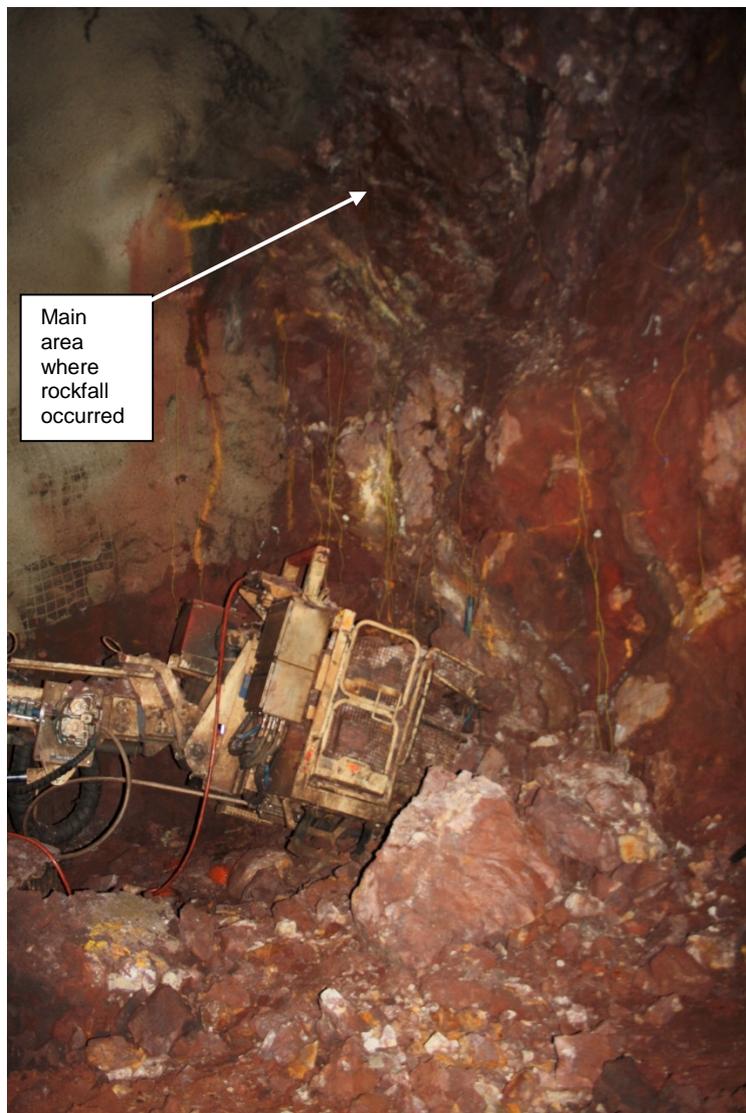
During charging of a perimeter hole on a development heading at an underground metalliferous mine, about 11 tonnes of rock fell from the middle and upper portions of the face, trapping an operator in a Normet Charmec basket, (see photo).

Following the fall, some of the rocks were hanging off the face from Nonel tubes (which had the potential to snap and shoot).

- The rock type was sheared and brecciated thinly bedded quartzite with pods of soft hematite alteration, which resulted in poor ground conditions.
- It was the first full cut after a turn out off a decline.

- In the days prior there had been a fall of ground from the backs of the turnout intersection.
- The face was large, approximately 6m wide x 8.2m high.

- The last row of bolts in the backs were between 0.25m and up to 1.6m back from the face.
- Geotechnical engineers had recommended the face be supported. That information was not effectively communicated, and as a result, not acted upon.

- The site had a system requiring operators to assess faces and determine the need for support.
- The jumbo operator had spent additional time to thoroughly mechanically scale the face, but did not consider it necessary to support it.

- The charge crew inspected the face and did not consider it needed hand scaling.

It is considered that routine face support is one of the most effective methods of managing the risk of rockfall at the face.

The mines inspectorate recommends all underground mines seriously consider adoption of routine face support in addressing this hazard.
