Working under a stope bridge

Mines safety alert no. 328 | 28 June 2016 | Version 1

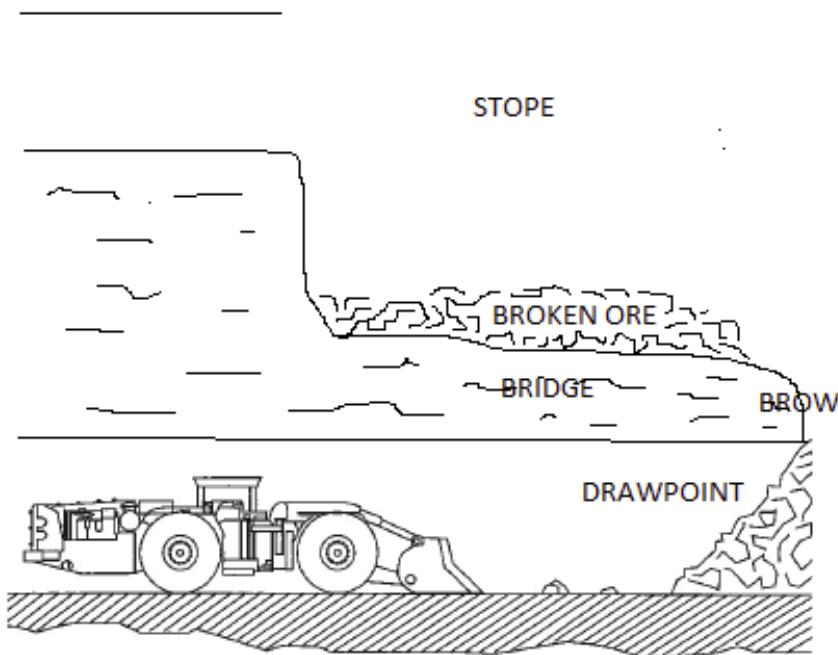
Production blasting to extract ore from an underground mine leaves behind an open space or stope. In this incident, following a production blast, material was left bridging the stope. The drawpoint is an opening at the bottom of a stope through which broken ore is extracted. Loader mucking operations took place in the drawpoint access drive, located beneath this bridging material (see diagram below).

In this incident several direct causes were determined:

- During the production blast parts of the blasting downholes above the extraction level failed to initiate causing a bridge to occur. The firing lines may have been cut at a clay band during firing.
- There were no markings to indicate where the intended brow position would be following the firing so personnel didn't recognise the brow was in the wrong place.
- Prior to the incident, a risk assessment had been completed recommending delineation of the last ring fired on all levels of a stope. The resulting procedure however did not clearly specify this delineation - so it was not done.

Review stope extraction risk assessments and associated procedures to ensure that:

- the risk of a bridge forming during a blast is reduced to an acceptable level, and adequate controls are in place to identify and manage a bridge should one occur. This should include consideration of the following:
 - Prior to firing include an appropriate method to identify the last ring fired on all levels, both on blast plans and at the actual locations underground.
 - Post-firing inspection by appropriate persons to confirm the blast has come out as planned, including confirming the locations of the various brow positions relative to their planned positions.

Where a bridge is suspected, prevent unauthorised access until the nature and location of the bridge is confirmed using appropriate methods such as by inspection, Cavity Monitoring System (CMS) survey or probe drilling, and the

- bridge is dealt with.

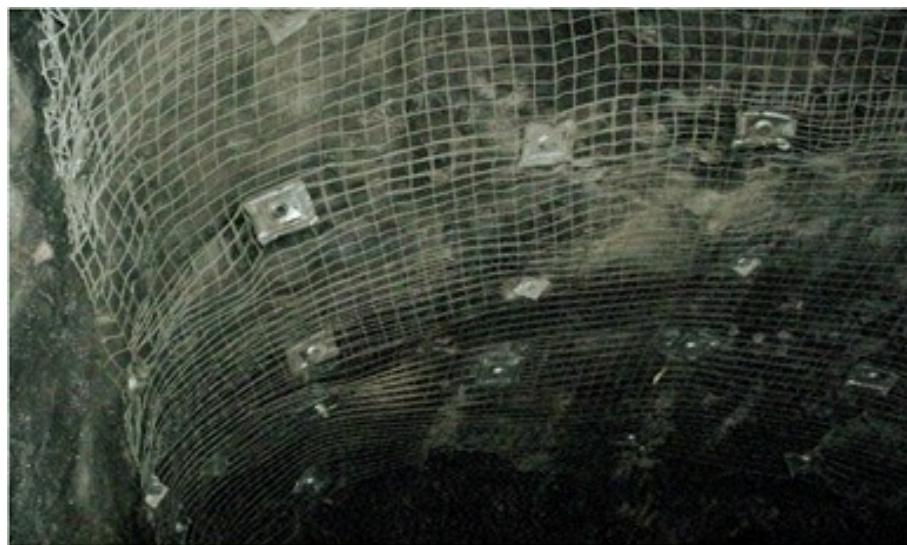
No disturbance from the production blast was visible in the meshed and rock-bolted extraction level (refer to photo) where mucking was occurring.
