Serious injury report

SERIOUS INJURY | SINNOT 2018/00993

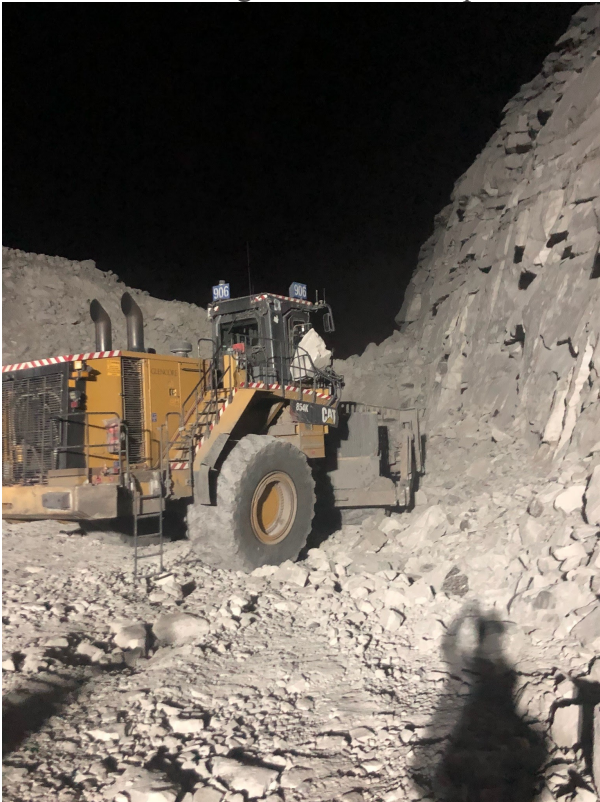
Summary: A rubber-tyred dozer was damaged when a rock fell from a highwall. The dozer was working underneath the pre-split high wall conducting clean-up work for the face shovel. A rock fell from the high wall and hit the right-hand side of the dozer. The impact caused damage to the electrical systems on the machine, shutting it down and disabling the radio. The operator had to flag down a haul truck operator for assistance.

Recommendations to industry: Risk assessments must be conducted establishing appropriate controls for hazards associated with highwalls before working under them. Workers must remain vigilant and not rely on other workers' inspections when working near highwalls.
