Excavator cabin detaches and falls

- **Incident date:** 10 October 2016
- **Event:** dangerous incident
- **Location:** Mangoola Mine, Wybong, Hunter Valley NSW

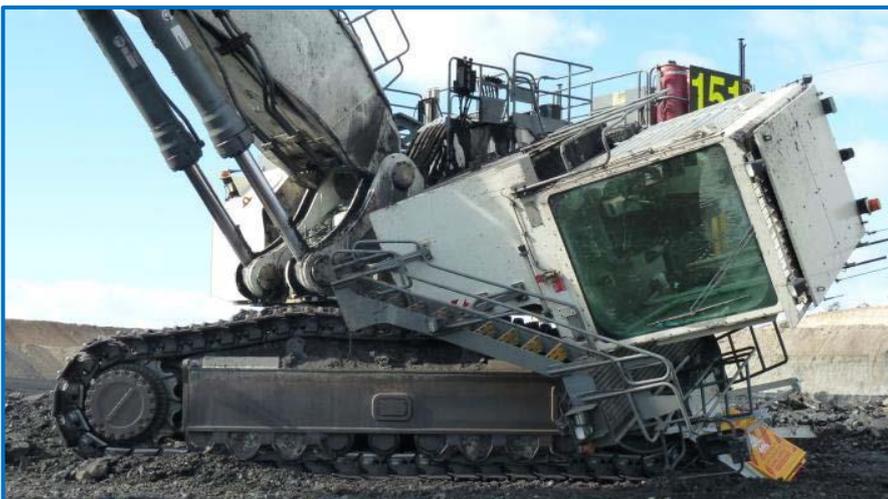
- While the operator of a 250 tonne Liebherr R9250 excavator (excavator) was inside, the cabin of the excavator dislodged and fell off the side of the machine. The incident occurred at 8.45 pm on 10 October 2016 during normal coaling operations.
- The mine's emergency rescue team was required to provide a safe means of egress for the operator out of the excavator cabin. The operator has since not been able to return to work.
- Before the incident, four of the six structural bolts securing the cabin had broken. The mine had carried out temporary repairs.
- The NSW Resources Regulator is undertaking further investigation. The integrity of structural components on plant and machinery (including structures) is paramount for the safety of people on the plant or in the vicinity of the plant.

Figure 1: Cab and riser of the excavator separated from the chassis. Photo supplied by the mine.

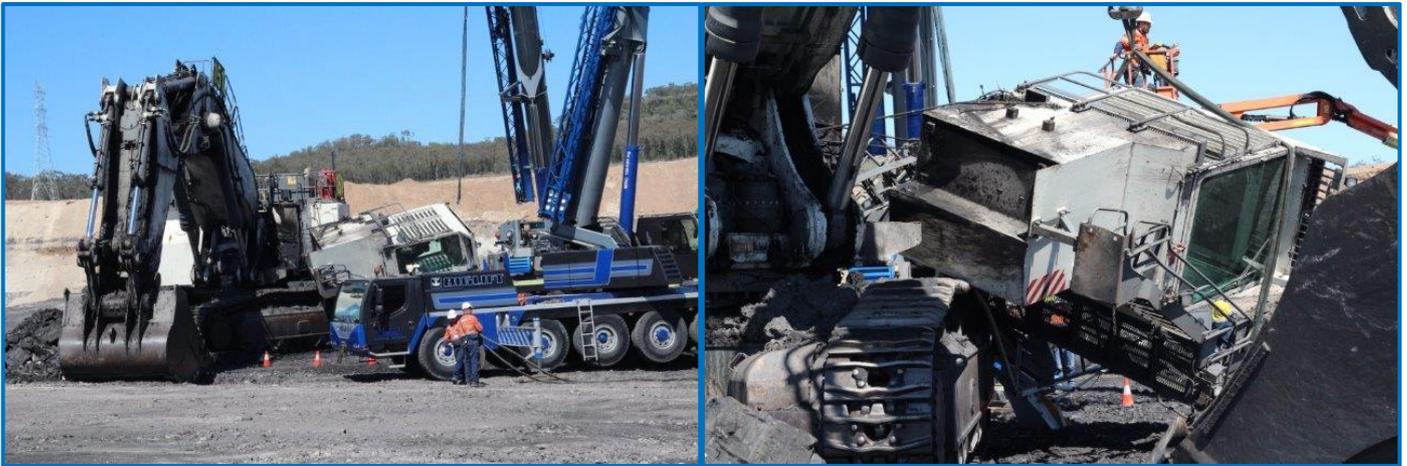
Figure 3: Operator's cabin on the excavator tracks, indicating failed horizontal bolts and interim weld repair.

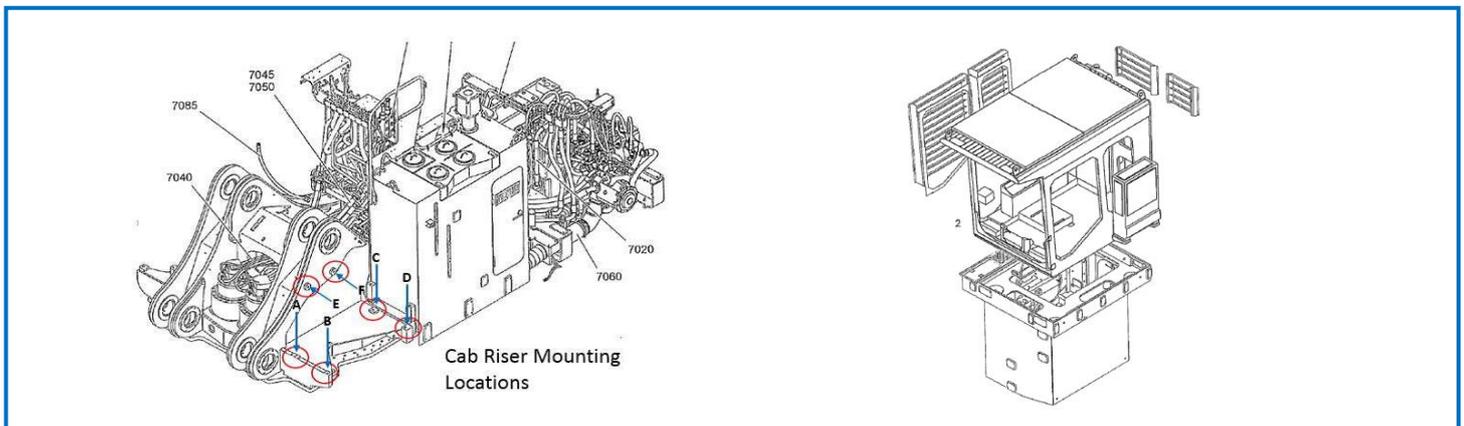
Of those six bolts, four were installed vertically through the floor of the riser (A, B, C and D) and two were installed in a horizontal orientation through the side wall of the riser (E and F). The bolts were installed from the inside of the riser to a threaded bore in the chassis. The bolts were specified as 30 mm in diameter, 300 mm in length and property class 10.9.

Figure 4: Cabin riser mounting locations

- 13 May 2016: two broken bolts were found by a mechanical tradesperson (bolts A and E on figure 4). A maintenance order was raised and the excavator returned to operation.

- 7 July 2016: a second attempt was made to replace the two broken bolts. This was unsuccessful and the excavator was returned to operation.
- 10 August 2016: a third broken bolt was found (bolt B on figure 4). Interim weld repairs were carried out following an informal assessment. The weld repairs welding the cab riser to the machine chassis at mounts A, B and E. Visual inspections were implemented and the excavator was returned to operation on 11 August 2016.

- 12 August 2016: a fourth broken bolt was found (bolt C on figure 4).
- 13 August 2016: further reinforcement (which included an additional gusset plate to mount E) was carried out to the interim weld repairs, along with more visual inspections. The excavator was returned to operation with the cabin being secured by vertical bolt D and horizontal bolt F (refer to figure 4) as well as an interim weld repair.

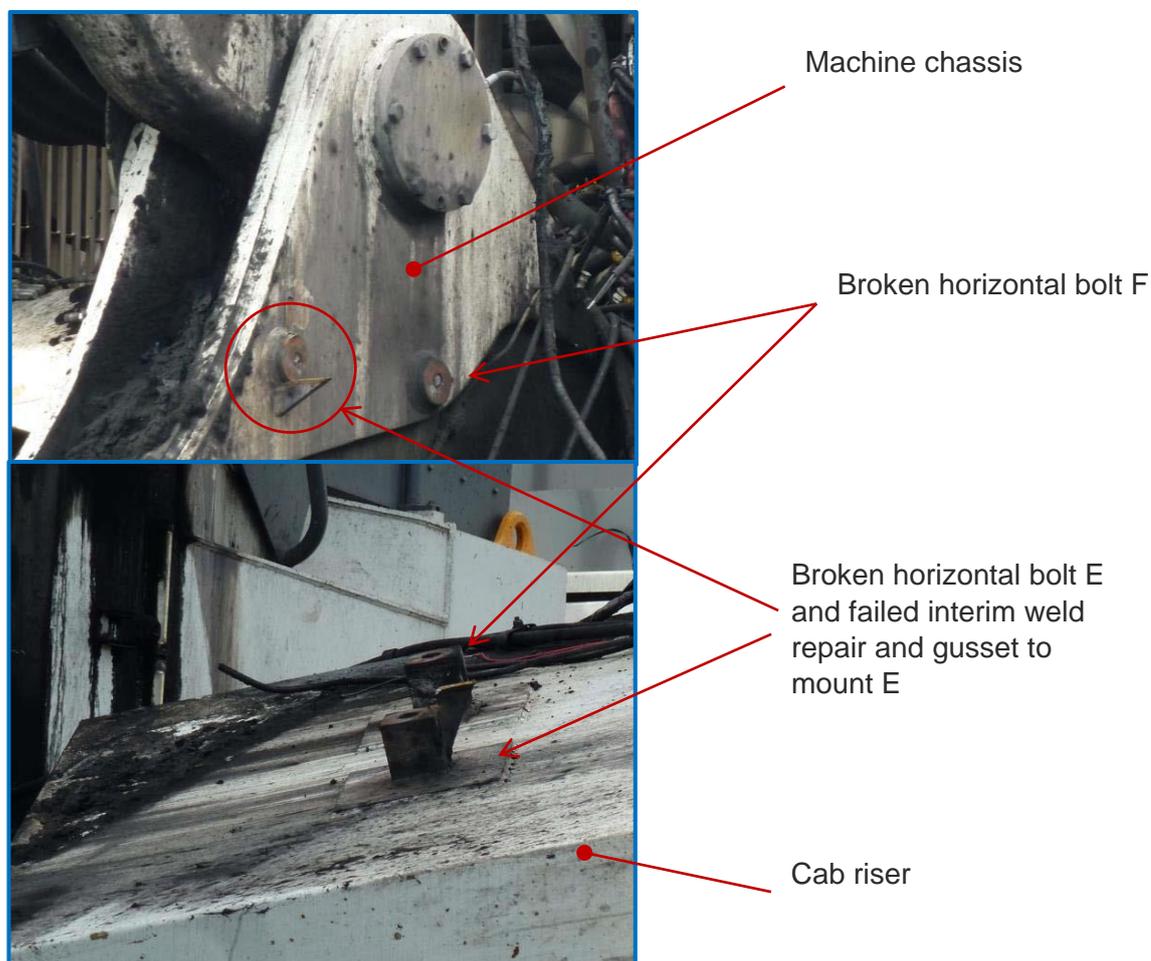
- 10 October 2016: the cabin dislodged and fell off, meaning the remaining bolts and interim weld repair had failed.

Figure 5: Failed horizontal bolts and weld repairs between machine chassis and cab riser.

Where interim structural repairs are carried out, then those repairs should be designed, detailed and checked by a professional engineer or the OEM. Those designs, including calculations and analysis, should be documented. The interim repairs must have sufficient strength to hold the loads imposed upon them for the expected duty.

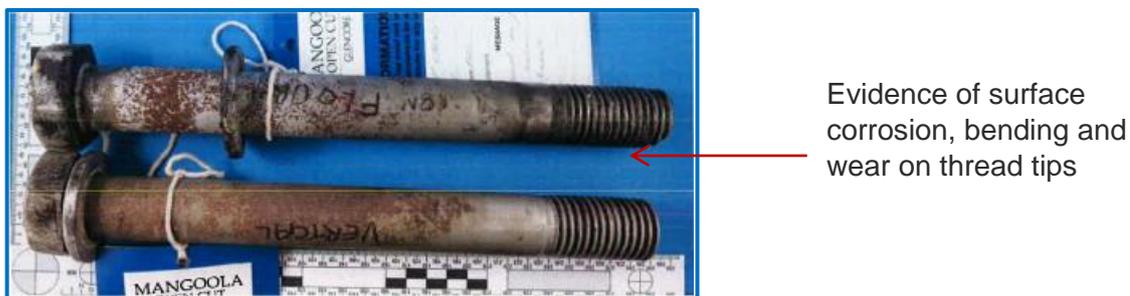
The two remaining bolts were found to have failed at the first engaged thread. This thread would have experienced the highest load.

The overall finding of the metallurgical analysis was that failure of the bolts used to join the cab and riser to the excavator chassis was attributable to a fatigue-related fracture of the front vertically installed bolt, resulting in loss of pre-load.

Figure 6: Two broken bolts found at incident scene.

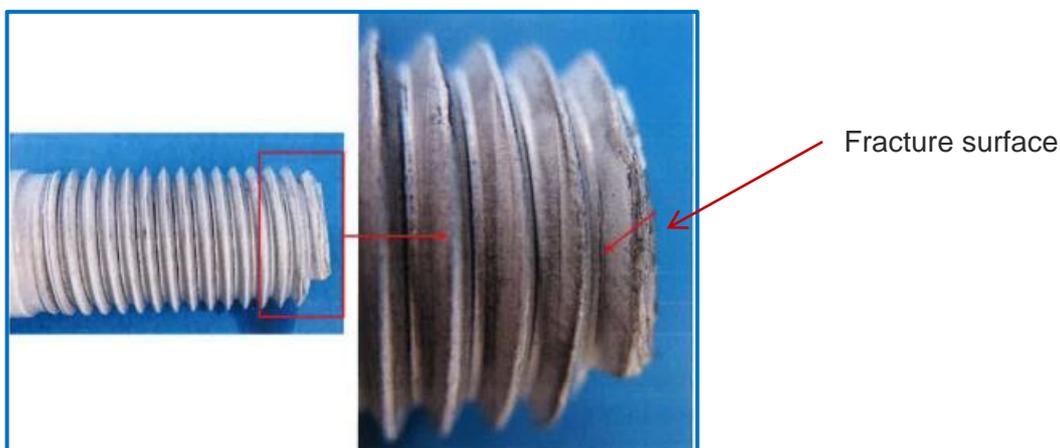
Figure 7: Floor bolt showing cracking within thread root.
