Week ending 15 March 2019

This incident summary provides information on reportable incidents and safety advice for the NSW mining industry. To report an incident to the NSW Resources Regulator call **1300 814 609**, 24 hours a day, 7 days a week.

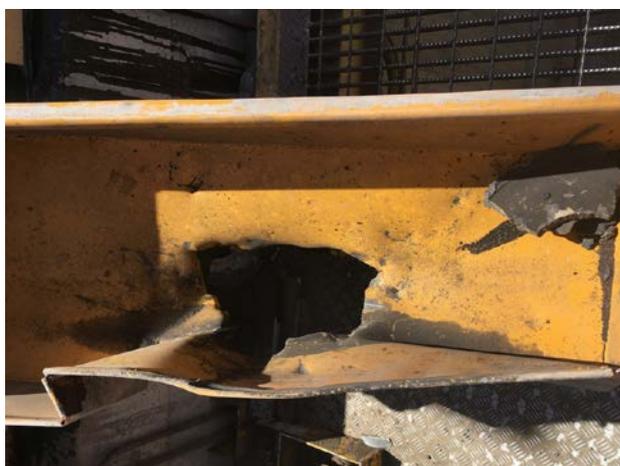
Incident type	Summary	Recommendations to industry
Dangerous incident IncNot0034149	<p>During a planned shutdown for the relining of a mill, a maintenance worker was slowly working the mill in an anticlockwise direction. The mill was stopped on completion. The crew saw the mill begin to move in a clockwise direction and increase in speed.</p> <p>The brake failed, followed by a loud bang and then metal parts were ejected from the brake unit up to a distance of 65 metres away.</p> <p>No workers were in the line of fire.</p>	<p>During maintenance activities the mill became unbalanced, causing it to rotate. Unbalanced loads must be considered as a potential energy source when completing and isolating work areas.</p>

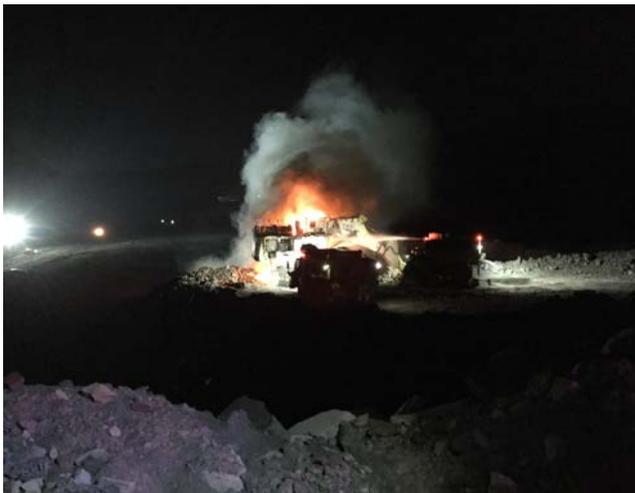
<p>Dangerous incident IncNot0034134</p>	<p>The operator of a 50T truck was travelling down the decline in a metalliferous mine when the truck dropped out of gear, causing the operator to lose control and hit the driver's side with the decline wall. The truck operator did not suffer any injuries, but the truck was damaged.</p>	<p>Defects that effect the safe operation of vehicles that are found during pre-use inspections and while operating must be reported and repaired. Mine operators should review pre-use inspections to include the immediate park up of equipment with safety-critical defects.</p>
<p>Dangerous incident IncNot0034122</p>	<p>A major fire occurred on an excavator. The machine had been back in service for one hour after maintenance. After the fire began, the suppression system activated and four water carts were used to control the fire. An internal fire continued, requiring the emergency response team to put out the fire. No injuries were reported.</p>	<p>This event is being investigated.</p> <p>Mine operators must treat the recommissioning of equipment after maintenance as equally important as the planning and completing of the maintenance itself.</p> <p>An inspection of potential fuel sources in the machines, such as rags, should be carried out.</p>

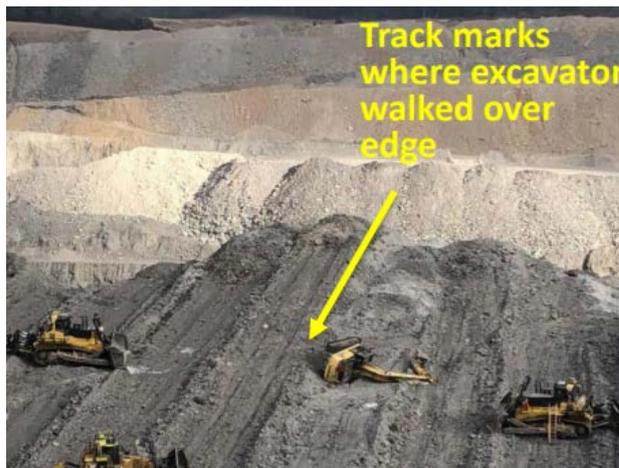
Dangerous incident
IncNot0034115

An excavator rolled over onto its side in an open cut dozer push area after a track went over a 0.5 metre to 1 metre drop. The operator suffered a 20 mm cut to top of his head and was able to extract himself from the machine.

Operators must inspect work areas before starting any task. Appropriate actions must be taken if the conditions pose a risk to people or equipment
