DATE: MARCH 2019

Welding-related electric shock incidents increase

This safety bulletin provides safety advice for the NSW mining industry.

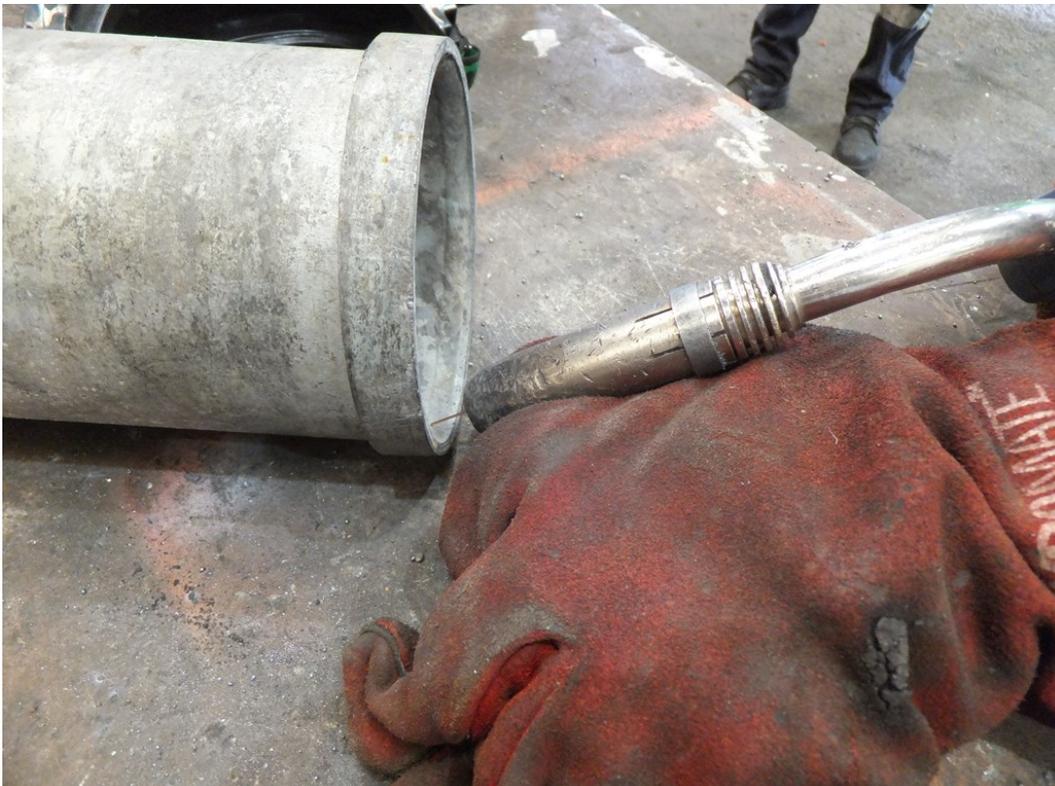
A worker was using a MIG welder in a surface workshop of an underground coal mine. The worker rested the handpiece tip on his gloved hand to steady the handpiece. The worker then felt a shock in his left hand.

Figure 1: Shock while welding pipe. (IncNot0033939). Photo by NSW Resources Regulator.

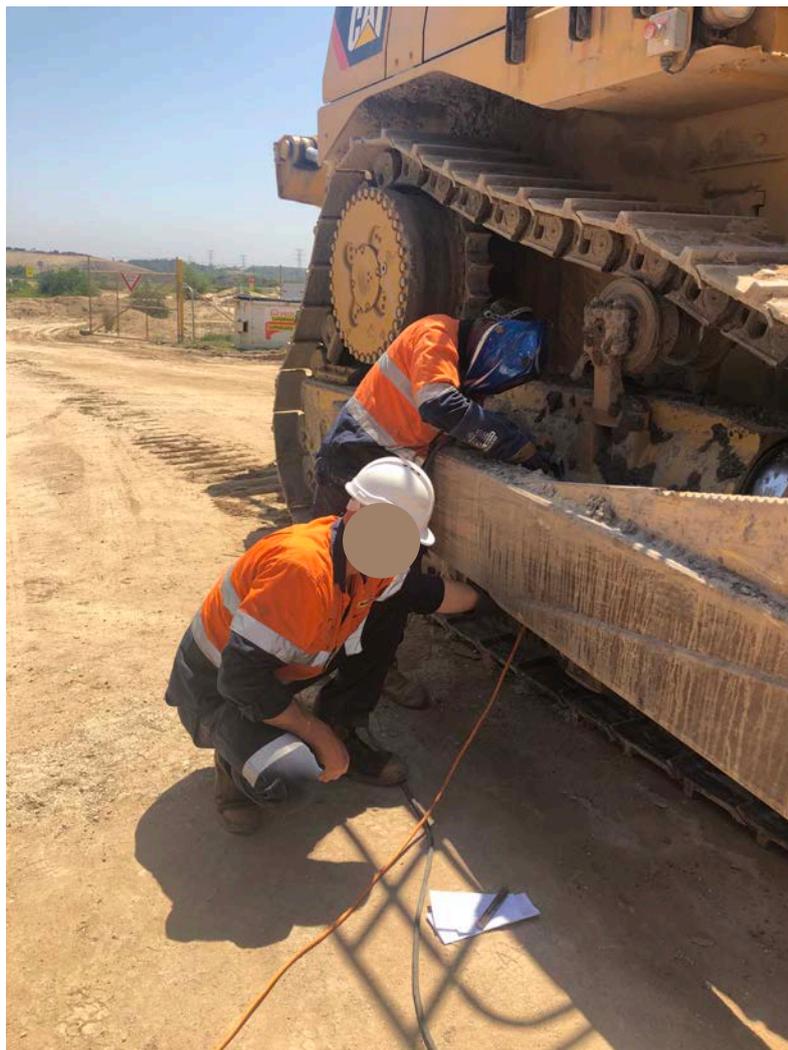
A fitter had washed down a dozer in a sand mine and was preparing to weld. Another worker saw the fitter positioned awkwardly so went to assist. After getting a welding glove, he held a pipe in place. The worker felt a tingle up his arm when the fitter struck the arc.

Figure 2: Re-enactment of assistant suffering an electric shock. (IncNot0033402). Photo by NSW Resources Regulator

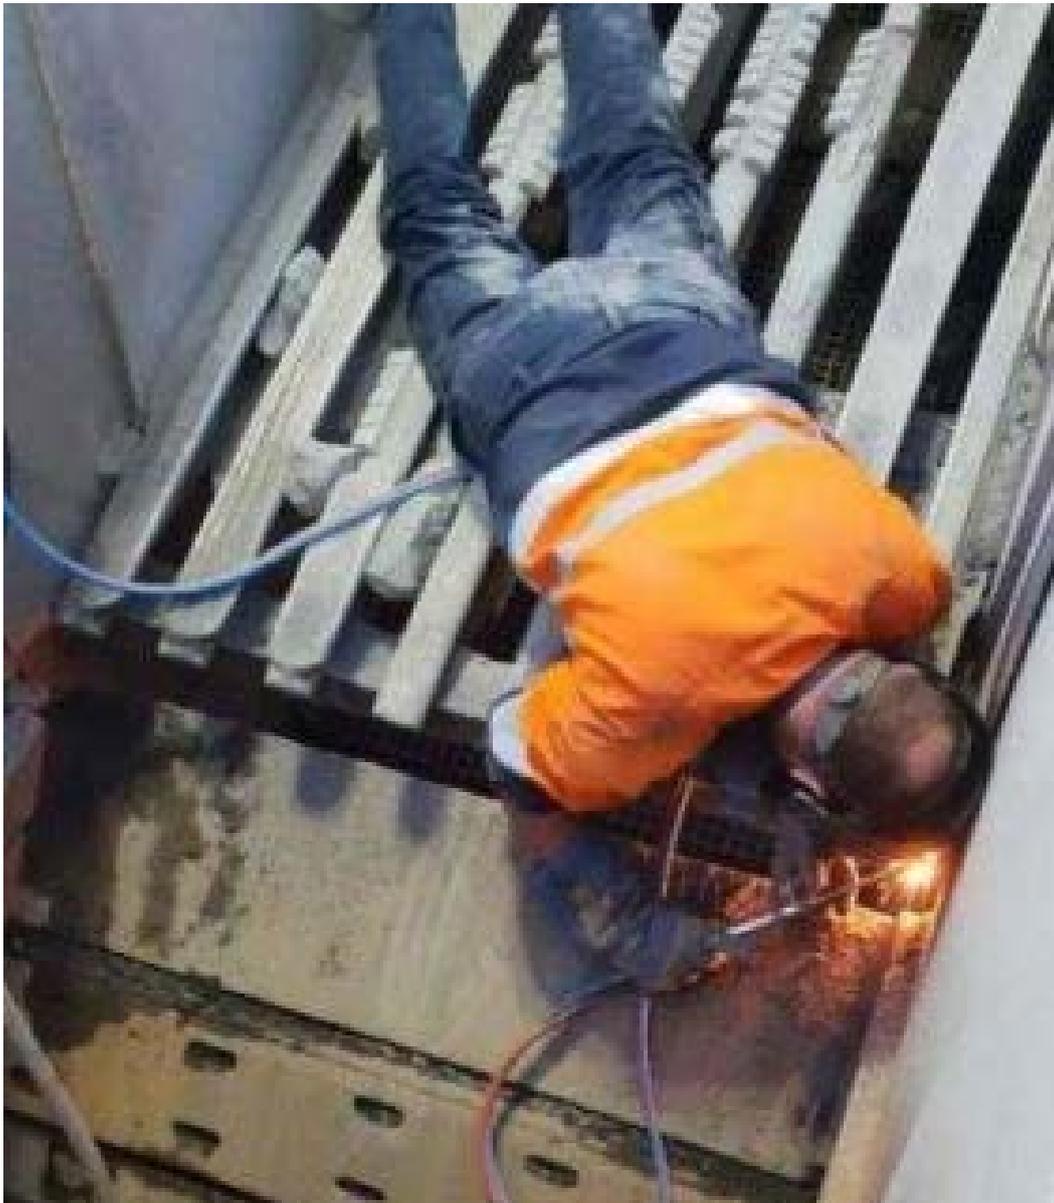
A contractor boilermaker was welding on grizzly panel in a quarry. The earth had been positioned on the opposite side of the grizzly to the area being worked on. The boilermaker was lying on the grizzly. When a programmable logic controller (PLC) code was loaded, a spray bar over the grizzly activated. The arc had already been struck, and welding was underway when the boilermaker suffered the shock.

Figure 3: The photograph was taken earlier in the day of the incident when the worker was in the same position at the time of the incident. (SInNot-2018/01982). Photo by NSW Resources Regulator

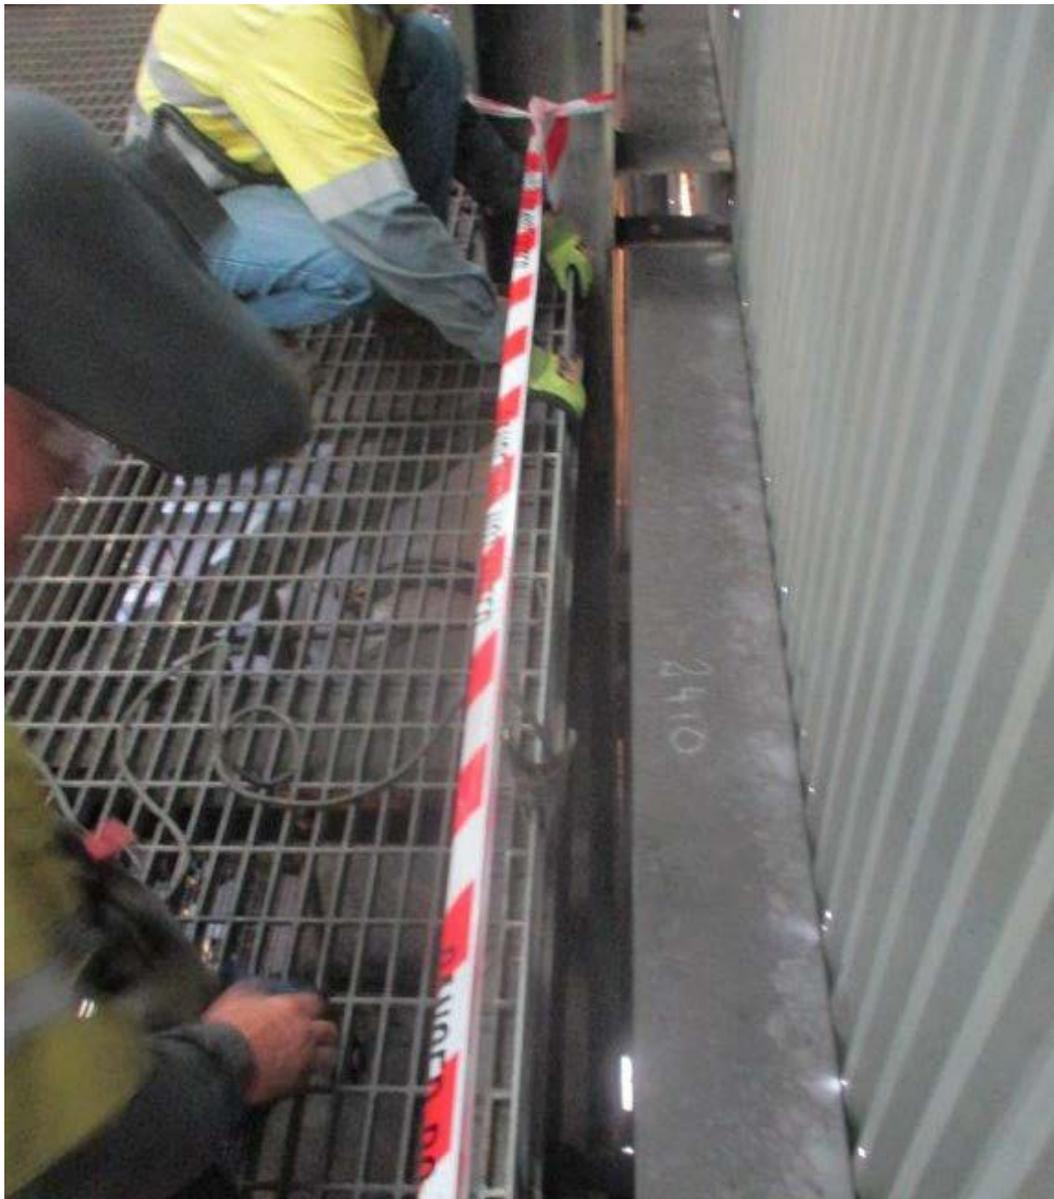
A trades assistant and boilermaker were repairing a walkway. The trades assistant was holding a kick board in position to be welded. As the boilermaker struck the arc, the trades assistant felt an electric shock through the right-hand glove. The trades assistant had his shoulder against a steel column. The boilermaker had the earth return on the opposite side to the trades assistant holding the work piece.

Figure 4: Haul truck hits light vehicle (SlnNot-2018/01932). Photo by NSW Resources Regulator
