# MINE SAFETY INSPECTORATE

INVESTIGATION INFORMATION RELEASE

## High potential incident

<b>Incident date</b>	2 August 2016
<b>Event</b>	Strainburst: E26 sublevel cave (SLC) ore drive 8
<b>Location</b>	Northparkes Mines

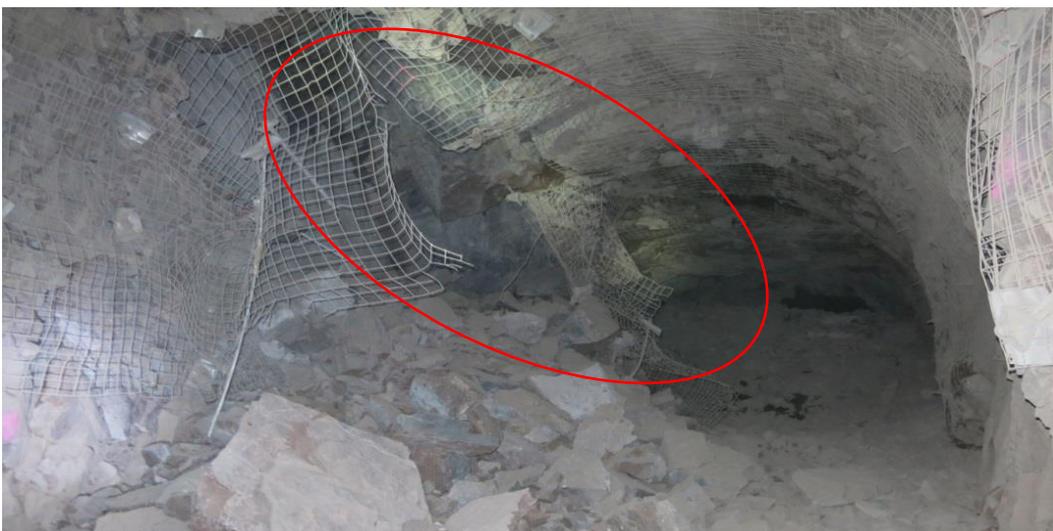
Figure 1: Strainburst from the left shoulder and resulting rockfall.

The tunnel failure resulted in the collapse of heavily fragmented material from the left (western) shoulder of the drive and some limited bulking in the side wall in front of the failure. The rockfall is shown in Figure 1. The installed support consisted of 2.4 m rock bolts and mesh. The installed rock bolts were shorter in length than the depth of the failure in the wall.

Damage of this nature is usually associated with an increment of movement on a pre-existing structure or structures. The movement causes excessive strain in the block formed by the structures and the excavation. That material then falls. The seismic event that occurred during or close to the time of the failure – in this case a local magnitude (ML) 1.2 – was a small proportion of the total energy dissipated during the failure.

1. The area was barricaded and the sublevel cave (SLC) was suspended for 48 hours to monitor seismicity. The incident was reported and the scene was inspected by Mine Safety, the Mining Manager, Operations Superintendent and Geotechnical Engineer.

4. An independent review of the incident was conducted along with a ground support review and recommendations, seismicity review of data and schedule sequence.

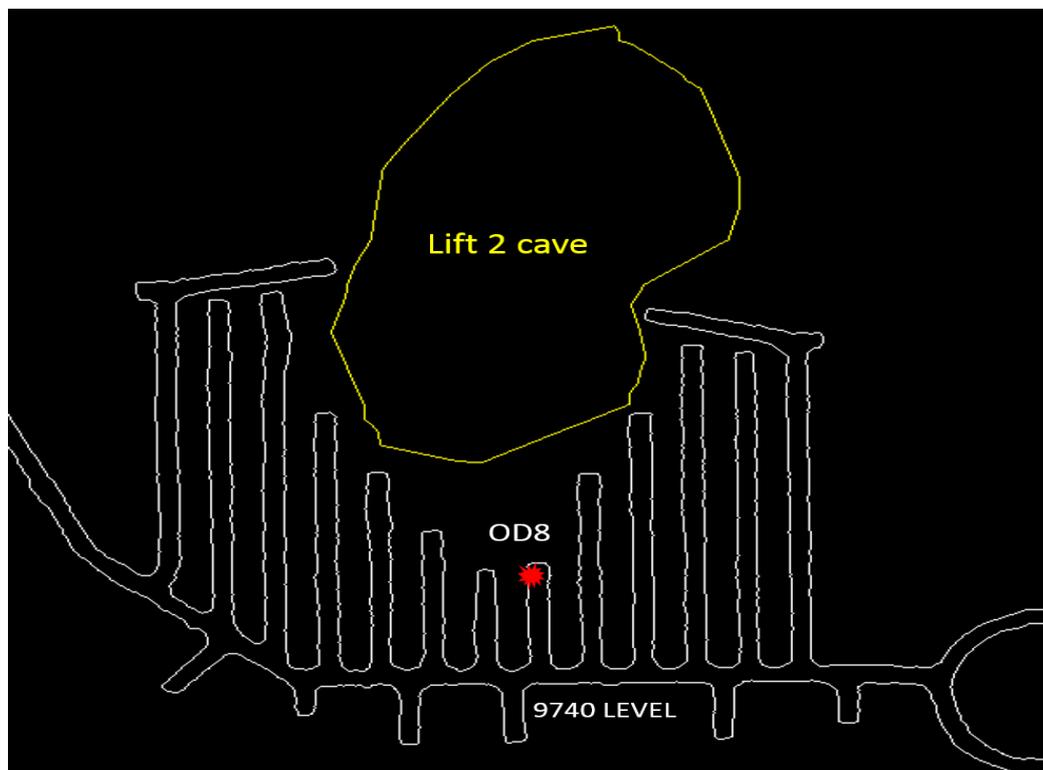
Figure 2: Location of incident

The incident site was ore drive 8 on the 9740 sublevel cave (SLC) shown in Figure 2. Ore drive 8 is a 5.0 m wide x 4.8 m high drive that was used to excavate 42 m through normal drill and blast practices. The previous 24 hours saw the heading excavated 6 m and at the time of the incident the heading was being fired for the next 6 m excavation (2 x 6 m firings in 24 hours).

The strainburst incident site was 10 m back from the face. A local magnitude (ML) 1.2 seismic event was recorded milliseconds after the face blast at 6 pm.

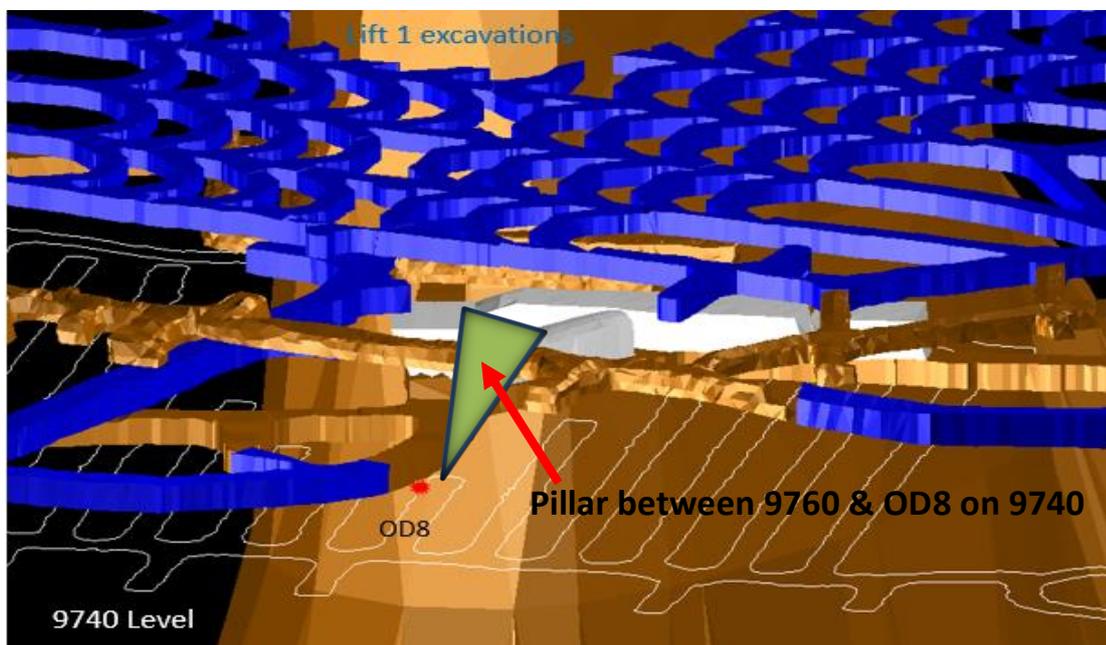
Figure 3: Location of the pillar

- The ore drive 8 crosscut was below and just offset from 9760 development and stopes. This proximity would further concentrate stress in the 'pillar' between ore drive 8 and the 9760 drive, even though the stress in the general area might otherwise be low, due to the de-stressing effects of the cross cuts.

- The crosscuts were mined 'outside in'. This would have further concentrated stress in the 'pillar' between ore drive 8 and the 9760 drive.
- Monitoring showed high, moderate and low intensity seismicity. In this case with the most intense rock noise, associated with yield through the pillar between 9760 and 9740 levels at the failure site. This is evidence of stress concentration in the 'pillar' and rock mass yield leading up to this fall of ground.

Considering these factors, it was likely that the excavation of the crosscuts incrementally increased the load in the pillar between ore drive 8 and the 9760 drive. At some point, that pillar yielded. The additional pillar strain manifested as dilation at the surface of ore drive 8.

6. The rate, cut length and stand-off times were restricted for the remaining drives to allow for stress redistribution.
7. The mine agreed to consult with other block cave mines in order to learn from others' experiences of strainburst.
