## Significant Incident Report No. 252

**Subject:** Fitter struck in chest by packing plate released under pressure

**Date:** 12 May 2017

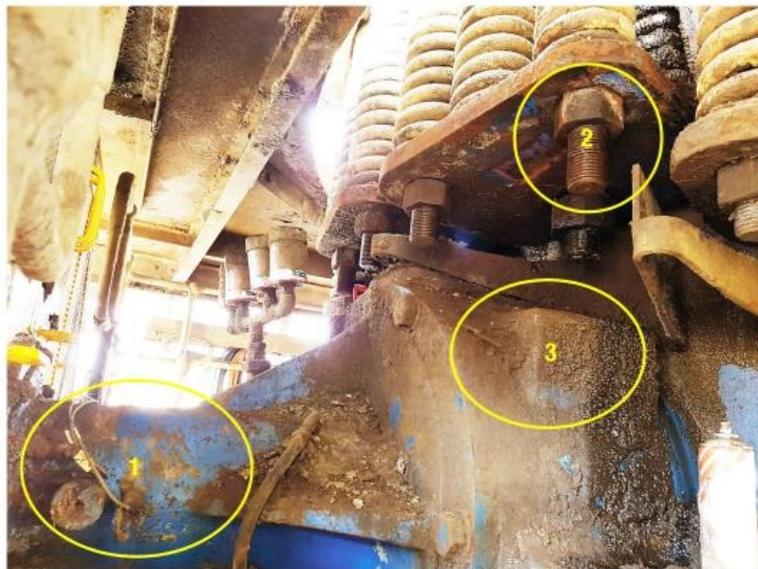
While a fitter was using a flogging spanner to release tension on a nut under the spring pack in front of him, a packing plate beneath the ram dislodged under pressure. The fitter, who was straddling the crusher's countershaft took the full-force of the plate to his sternum, receiving a significant chest injury.

1. Countershaft the fitter was straddling. 2. Nut that was being un-tensioned. 3. Countershaft ledge on which the ram and steel plates was positioned.

- The countershaft ledge on which the hydraulic ram was positioned was covered in mud and oil, not level and installed out of alignment with the spring pack.

- The steel packing plates were contaminated by oil (reducing the friction on the packing plate surface) and positioned offset to the hydraulic ram, increasing the potential for release during equipment movements.

- Undertake a documented risk assessment of all plant in the workplace to identify, assess, evaluate, control, monitor and review all hazards to which workers are likely to be exposed.
- Implement a robust maintenance system that ensures:
  - availability of critical plant components
  - a timely response to loss of serviceability of plant components
  - regular inspection of plant by a competent person
  - plant is maintained in a safe condition.
- Promote hazard reporting and appropriate response to reduce the potential for inaction and sub-standard conditions to be tolerated.
