CAUSAL INVESTIGATION

# Catastrophic engine failure in an underground coal mine

Title: Causal investigation: Catastrophic engine failure in underground coal mine

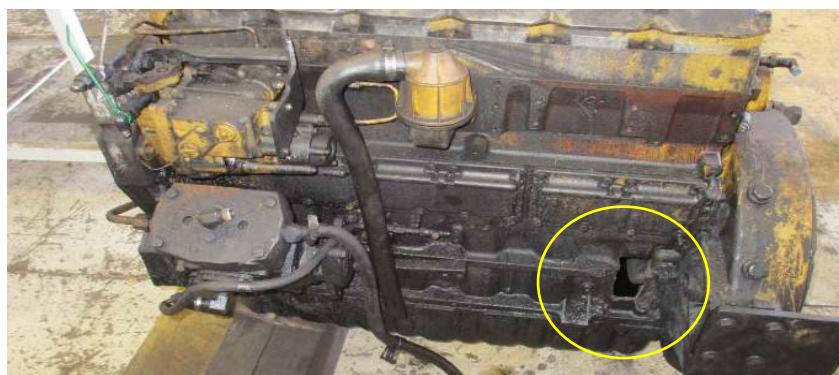
In the early hours of 4 July 2017, the Caterpillar 3126 DITA engine in the FBL10 (the engine) catastrophically failed in the main intake airway of the mine. The failure caused internal engine components, including the connecting rod end cap and fragments of the piston skirt to be ejected from both sides of the engine block (adjacent to No 6 cylinder bore).

**Figure 1: The hole in left rear of cylinder block (circled below) after the parts were ejected from it.**

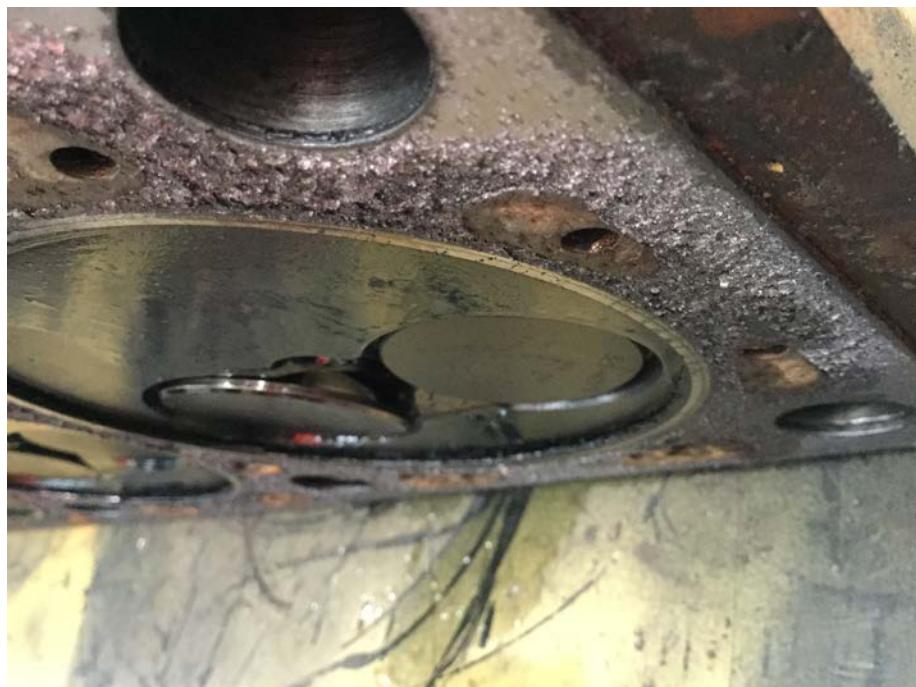
Figure 4: Valve head from No 6 is not seated indicating bent valve shaft.

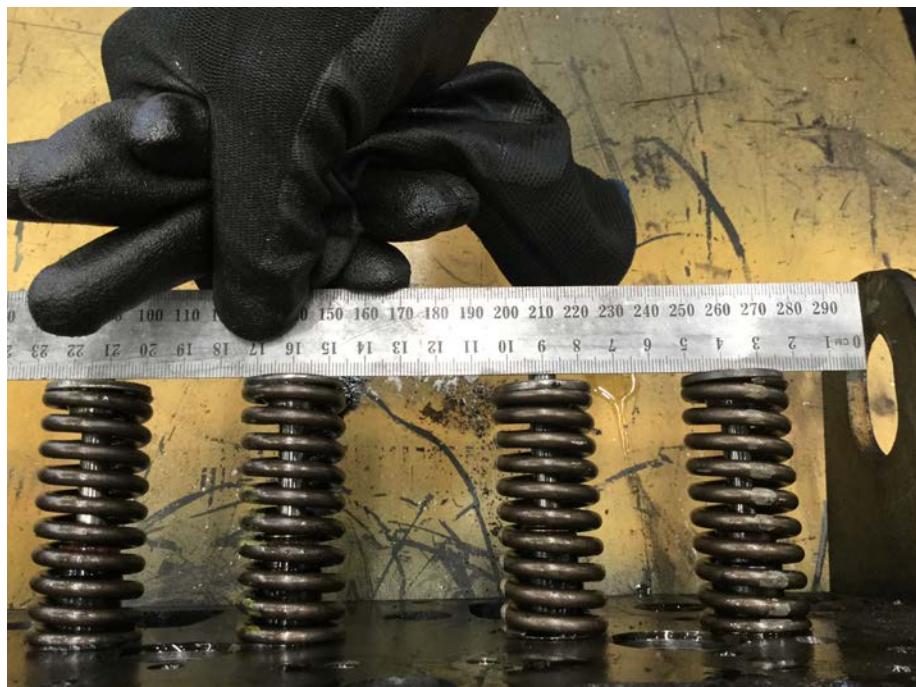
Figure 5: Valve second from left shorter than others due to bent shaft.

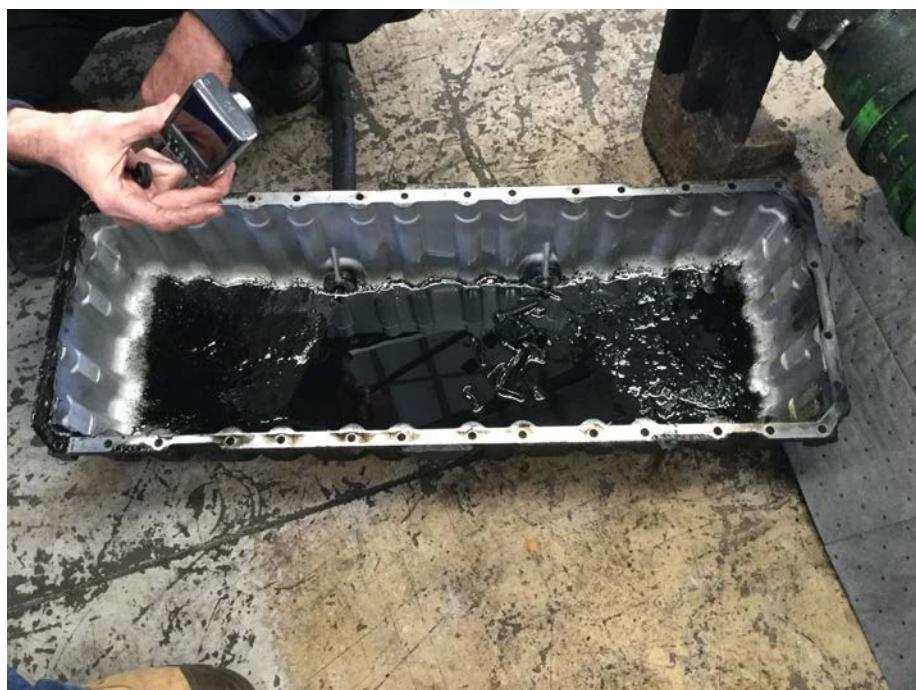
Figure 6: Debris found in sump (fragments of the piston skirt and conrod bolts).

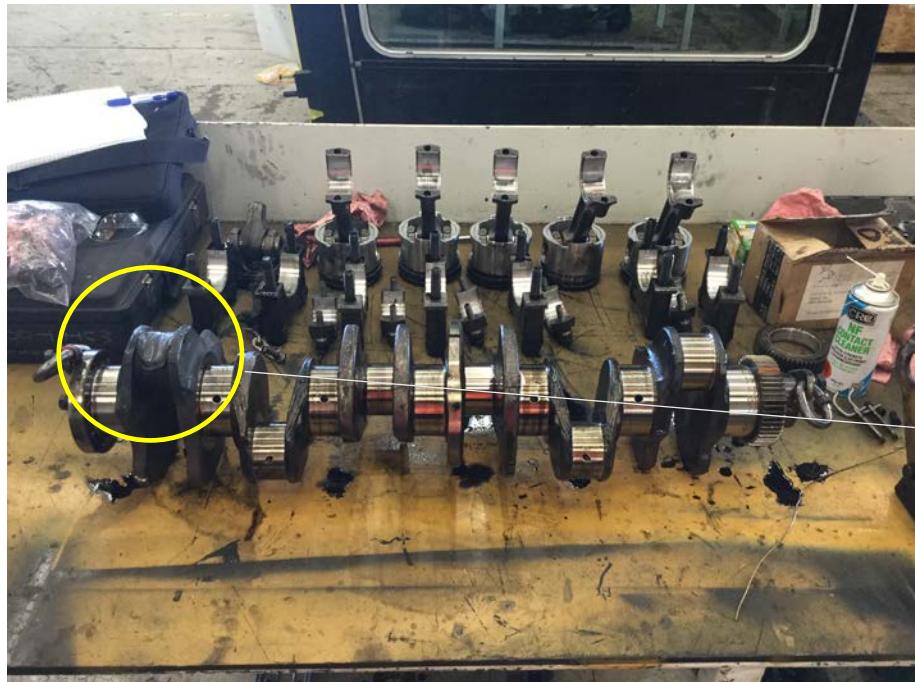
Figure 7: Crankshaft, main bearings caps and pistons complete with conrods (1-5) on bench. Can see No 6 blackened bearing journal.

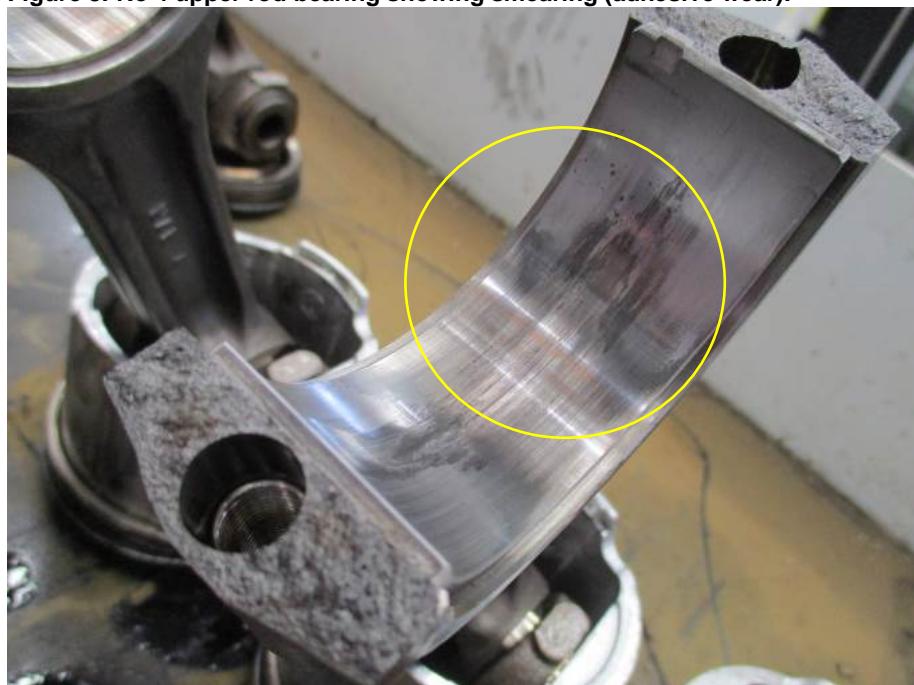
Smearing is adhesive wear and smearing on bearings indicates that there has been a system problem at some time that produced marginal lubrication to the bearing. The No 4 rod bearing showed signs of adhesive wear with corresponding discoloration on the crankshaft journal. This typically is a lubrication-related issue.

Figure 8: No 4 upper rod bearing showing smearing (adhesive wear).

wear on No 4 rod bearings may indicate the root cause of the failure of No 6 rod bearings, as adhesive wear is a precursor to bearing failure.

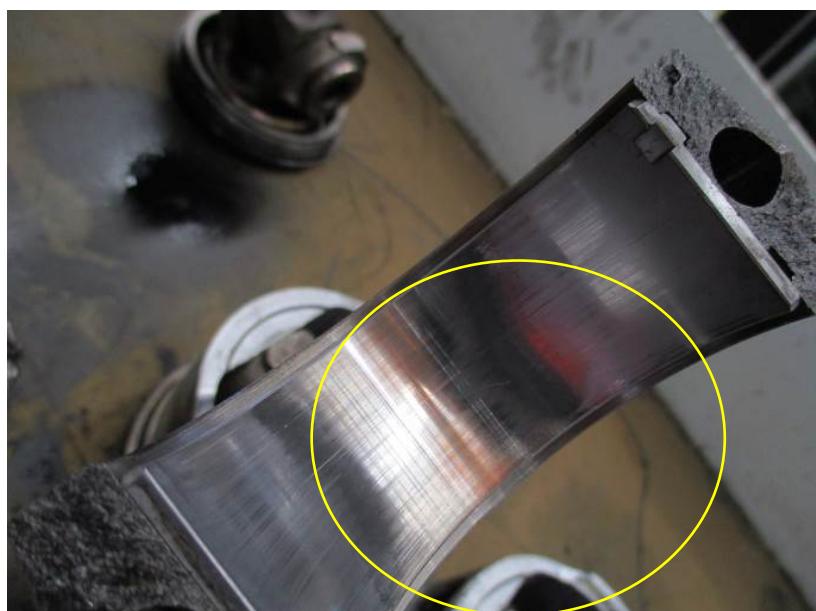
Inspection of the remaining five upper rod bearings showed that the copper bonding layer was visible, which is typically indicative of fine debris wear.

WesTrac advised the causal investigation team that the lead-tin overlay on the bearings was 1/1000 of an inch thick. The copper bond layer was 1/10,000 of an inch thick. It is only when abnormal abrasive wear occurs that the lead tin overlay bearing will display a copper color. This could indicate there has been abnormal abrasive wear created by oil with debris in it. The copper bond layer that can be seen in figure 9 indicates that the top two layers have been worn through.

**Figure 9: Upper rod bearing No 5 showing a copper bonding layer often associated with fine debris damage.**

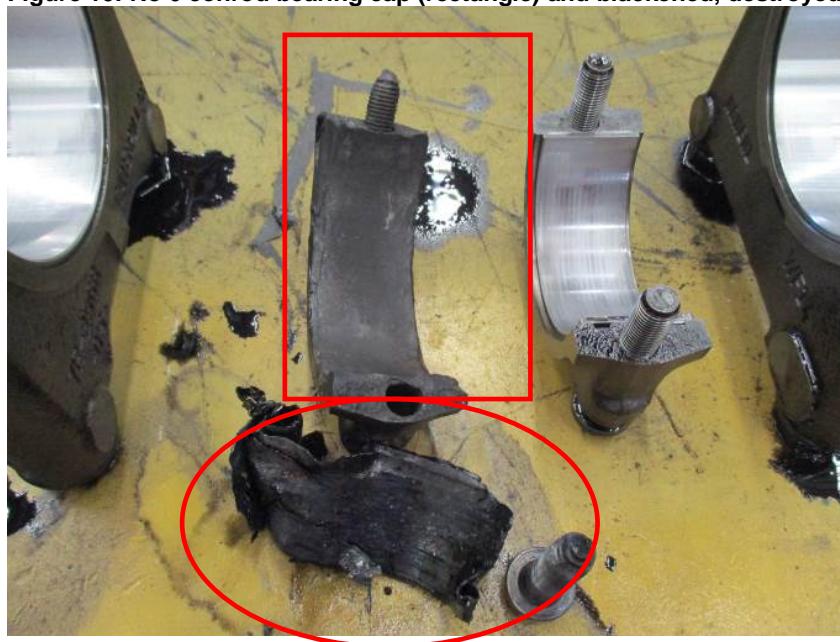
The recovered No 6 rod bearing cap was found to be black in color indicating excessive heat.

**Figure 10: No 6 conrod bearing cap (rectangle) and blackened, destroyed No 6 bearing shell (oval).**

*Failure of the No 6 rod bearing is typical of a marginal lubrication failure. Marginal lubrication can be classed as an oil quality or oil quantity related failure. The extent of the damage to the No 6 rod and bearing components makes it impossible to determine the cause. Observation of the remaining bearings did note fine debris damage to the upper rod bearings and some adhesive wear on the No 4 rod bearings. The adhesive*

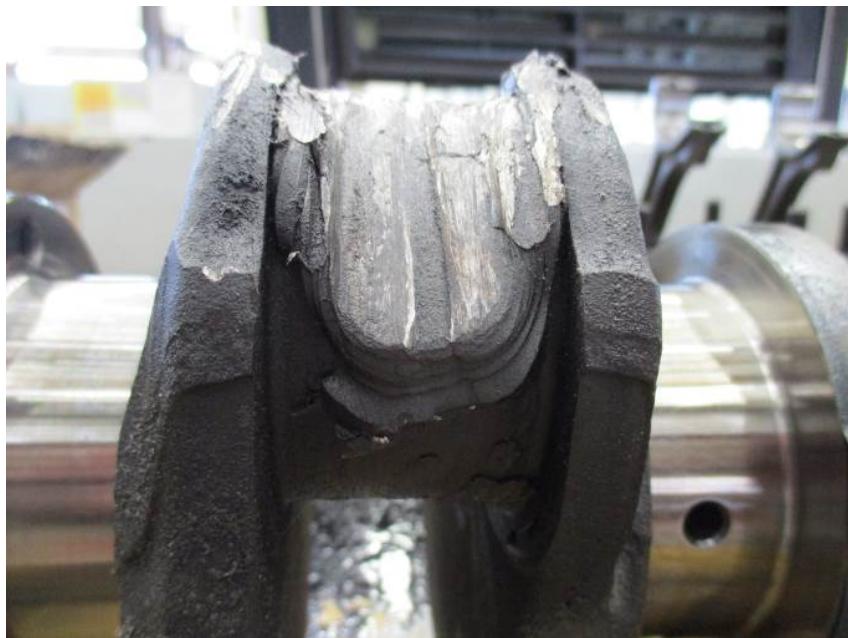
**Figure 11: No 6 rod journal became so hot that impact with the connecting rod caused material flow and left an imprint of rod profile on the crankshaft.**

- no evidence could be found to indicate that the catastrophic engine failure was a result of an engine over-speed event
- molten metal flow does indicate that extreme temperatures were reached, which were clearly above the hot surface ignition temperature of an explosive range methane.

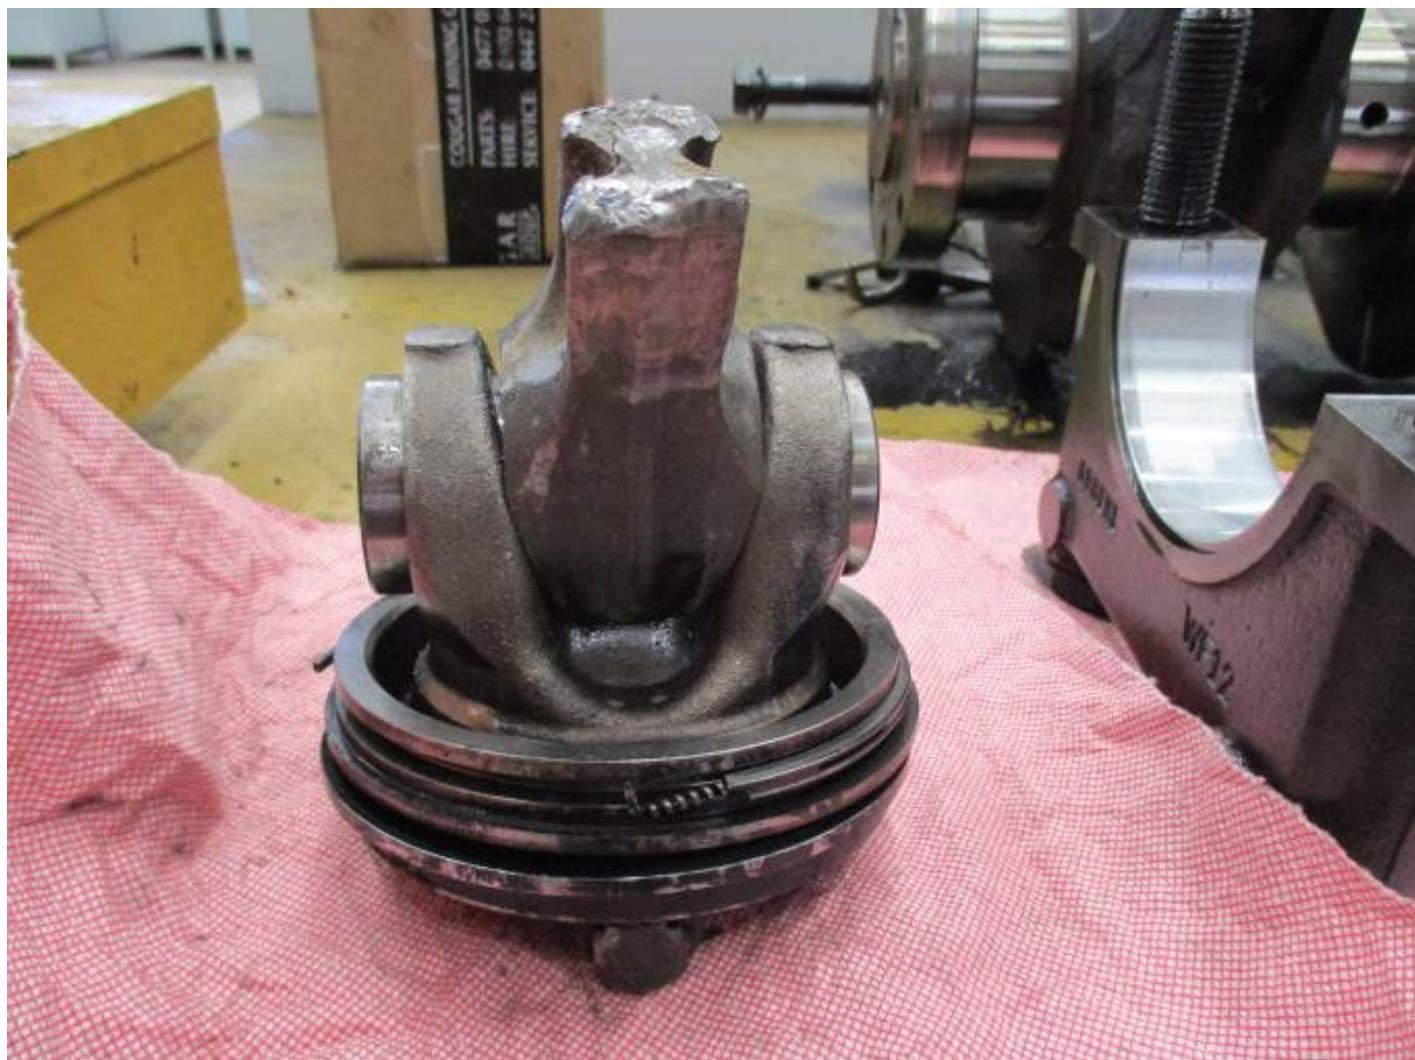
The most likely cause of the No 6 conrod bearing failure was a lack of oil, and/or poor oil condition. As a result, the excessive heat created a failure of the bearing and connecting rod. Once the connecting rod failed, further contact of broken components with the rotating crank shaft caused the parts to punch a hole in both sides of the engine block. It was this which ultimately led to the catastrophic engine failure.

**Figure 12: Piston and wrist pin with remainder of conrod attached (other part never found).**
