# **Investigation report**

Report into the death of Stephen Norman  
at the Rix's Creek Coal Mine, Singleton, NSW,  
on 13 December 2016

First published: November 2018

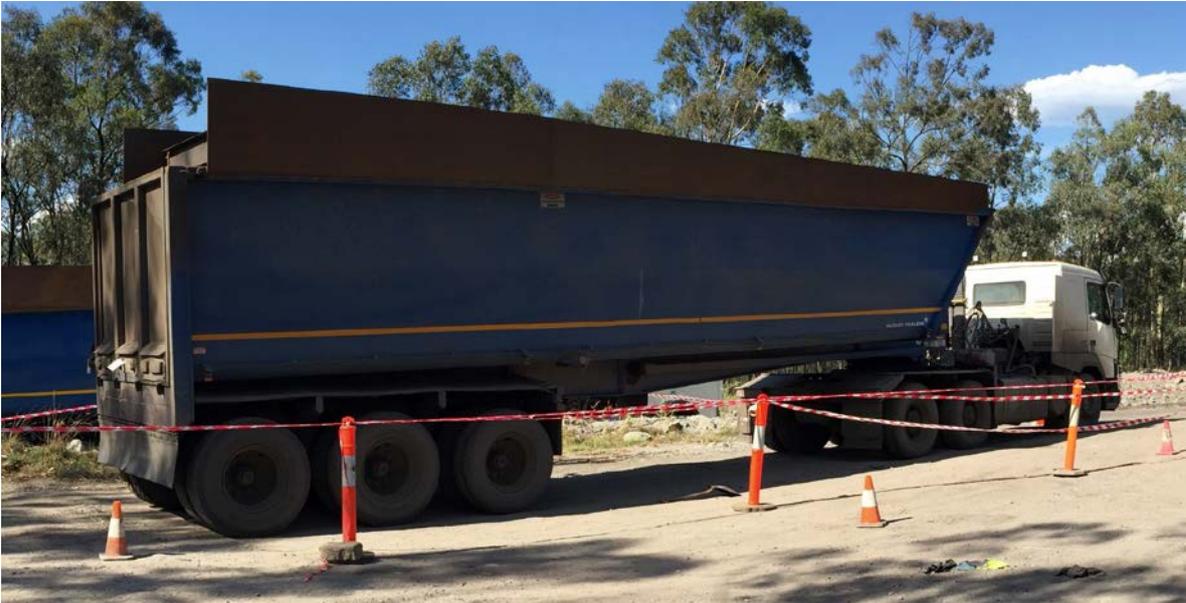
Figure 4: Truck and Muscat trailer involved in the incident.

The coal haulage truck was a Volvo prime mover (registration CG 50 MV) with a Muscat MT2103 tipping trailer (registration W68252) as shown in figure 4.

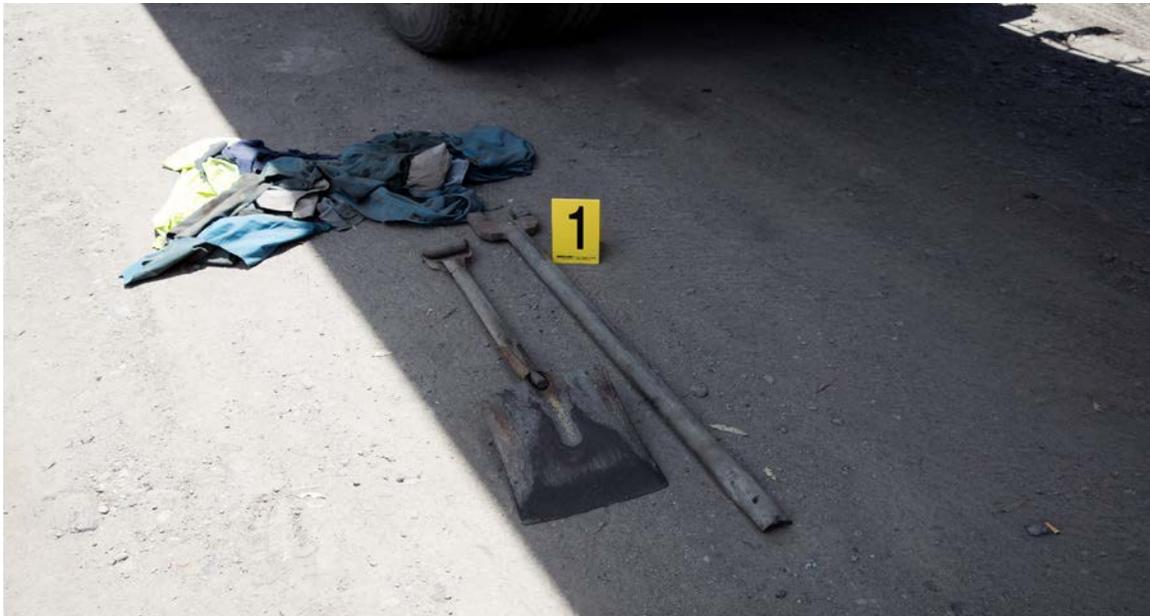
Figure 5: Handmade tool and shovel.

Mr Norman used a shovel to pry open the tailgate and propped it open with a handmade tool (pipe wrench) as shown in figure 5.

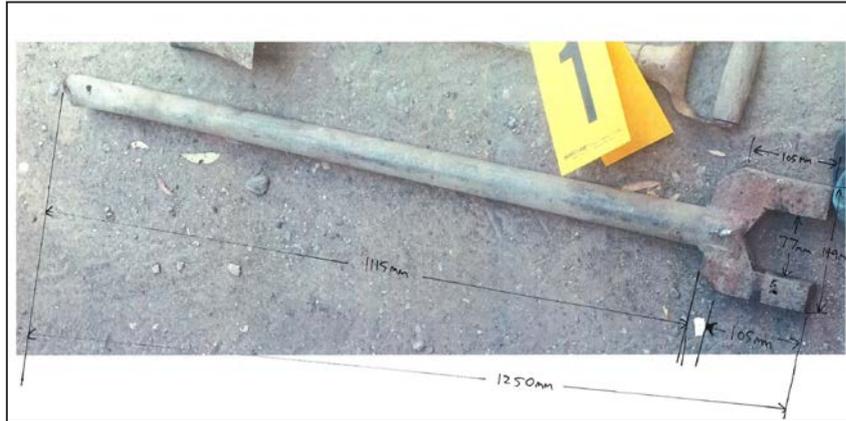
Figure 6: Handmade tool used to prop open the tailgate of the Muscat trailers.

The tool used as a prop during the incident was a handmade tool described as a pipe wrench or breaker bar. It was 1250 mm in length as shown in figure 6. This tool had been on the site for many years and was used by Mr Norman for several different functions that he carried out at the mine site.

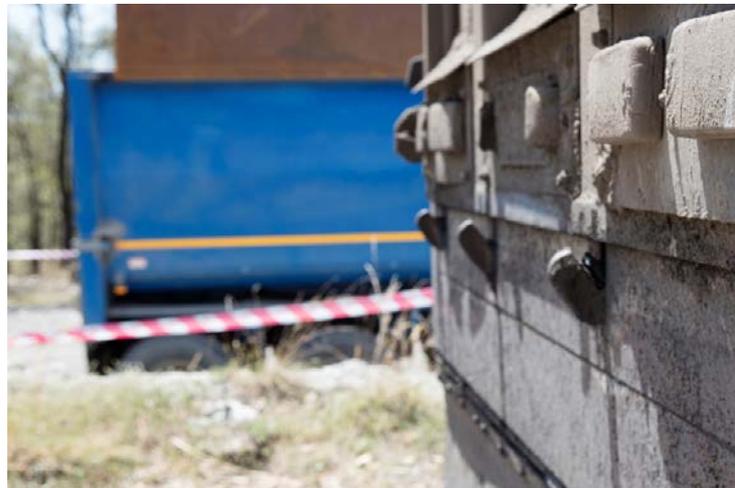
Figure 7: Trailer locking devices.

The Muscat trailers have mechanical locking devices on the rear known as fingers, which are used to keep the tailgate closed.

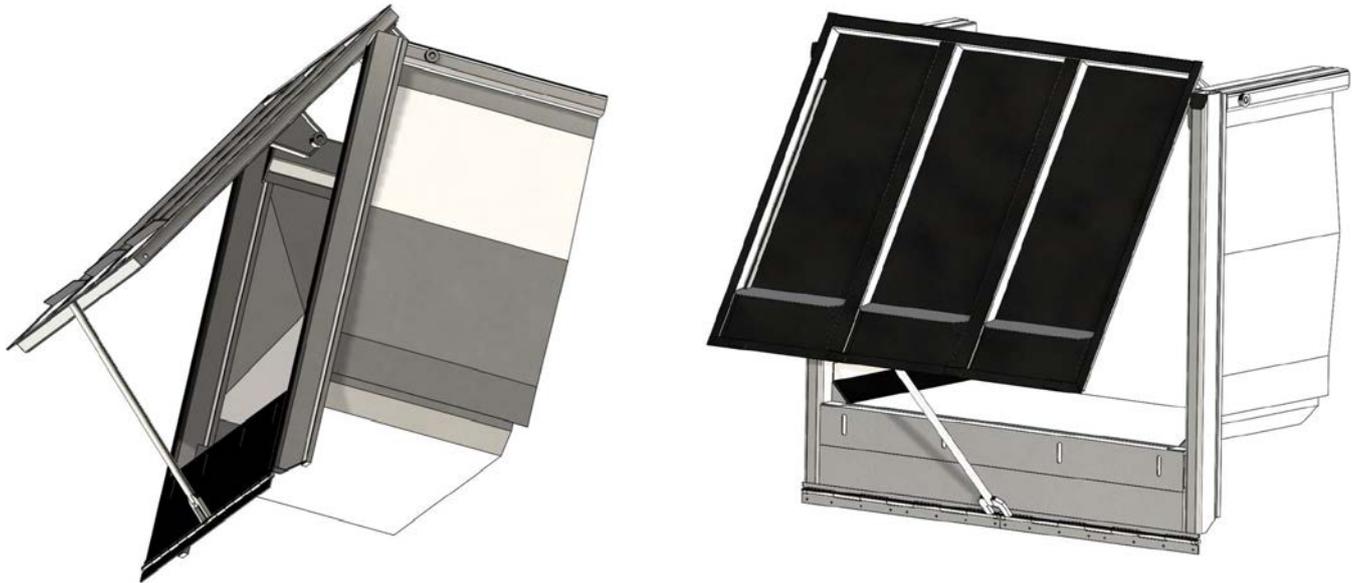
Figure 8: Position of the prop to open the tailgate.

The exact location where Mr Norman attempted to prop the tailgate cannot be definitively established.

A witness stated that Mr Norman placed the prop with the pipe end under the lip of the tailgate and the forked end with the forks in a horizontal position against the hinges at the rear of the trailer, as shown in figure 8.

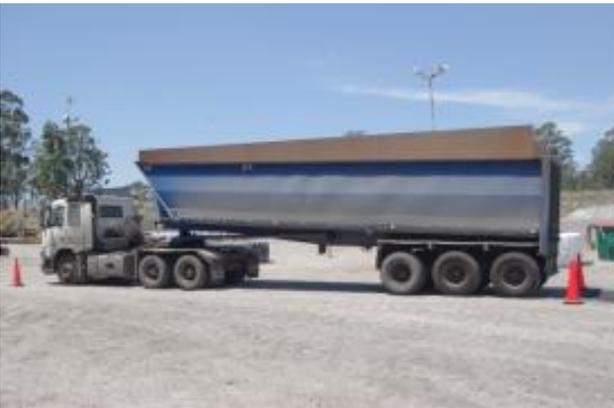
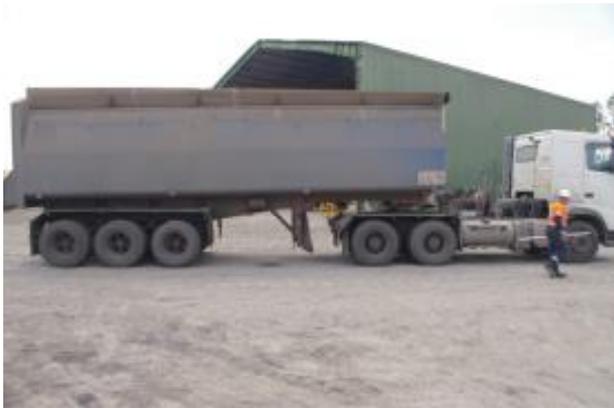
Figure 9: Differences between the Marlin and Muscat trailers.

<p>The Muscat trailers were 2130 mm longer than the Marlin trailers.</p>

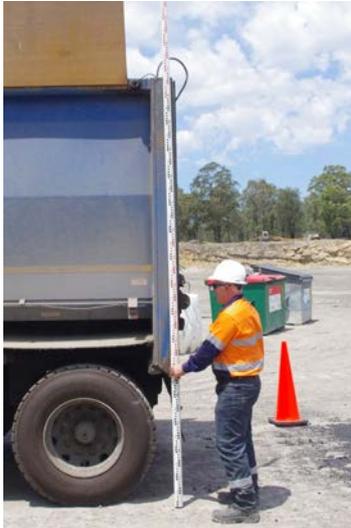
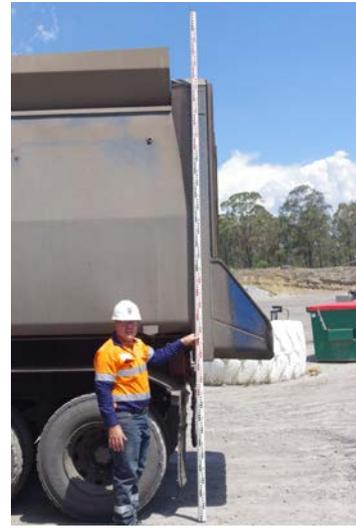
The floor of the Muscat trailer was 150 mm lower to the ground than the Marlin trailer, which made it easier to attempt the manual lift.

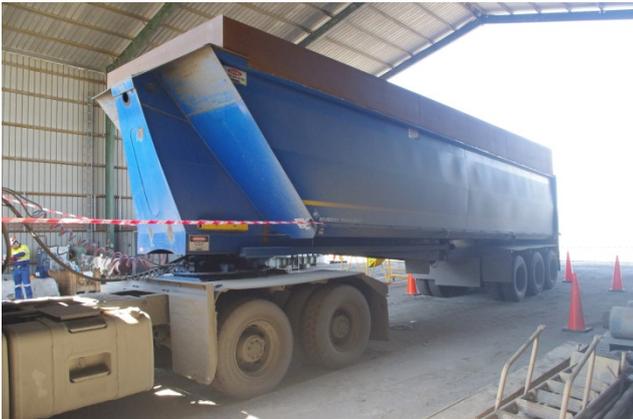
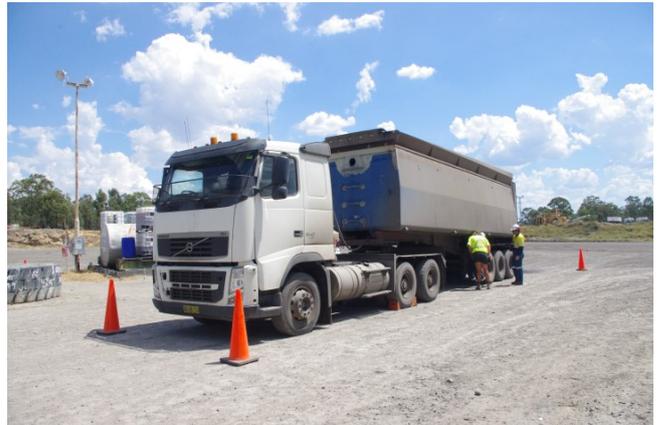
The Muscat trailer did not have any outside access into the trailer whereas the Marlin trailer had vertical access rungs on the front of the trailer.

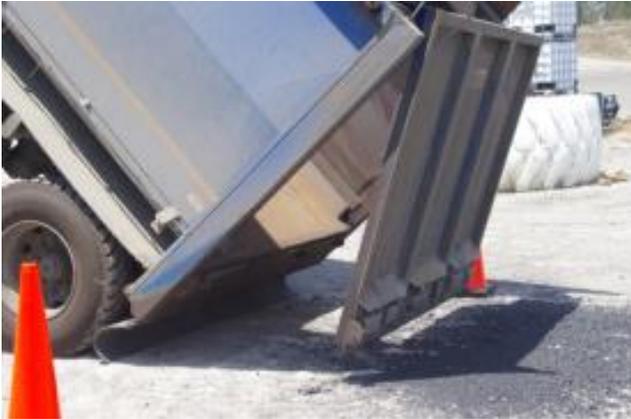
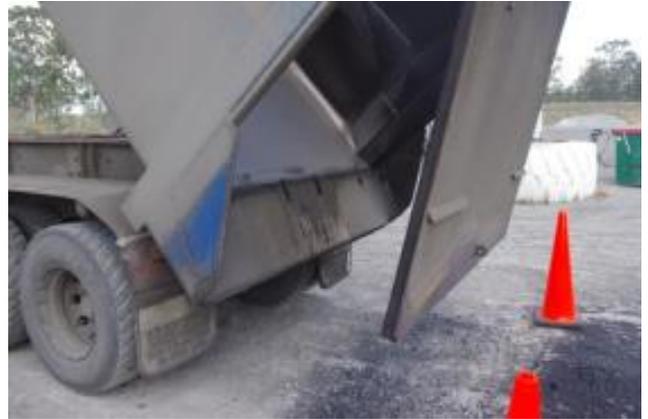
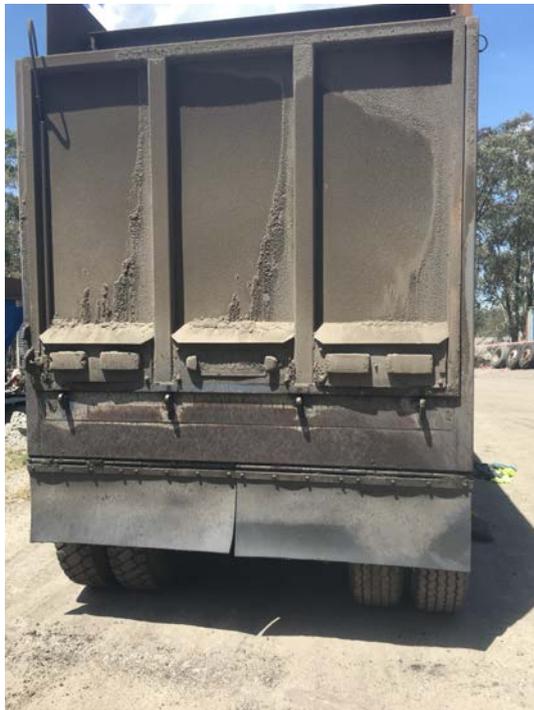
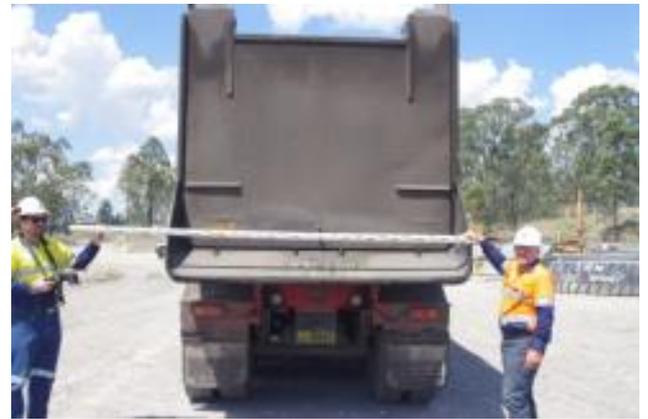
The tailgate on the Marlin trailer had an extension lip on the tray that protruded past the tailgate.

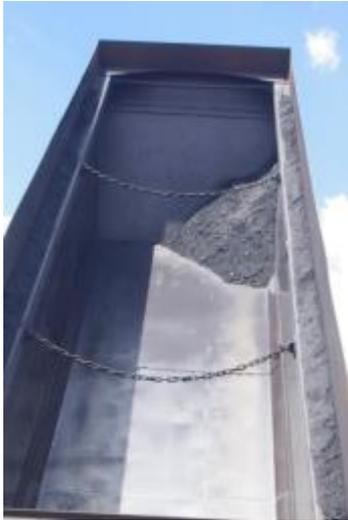
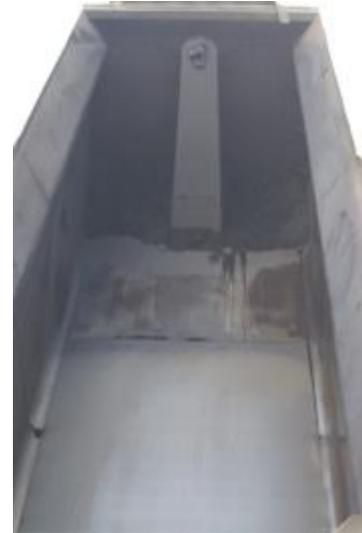
The Muscat trailer did not have the hoist intruding into the trailer whereas the Marlin trailer did.

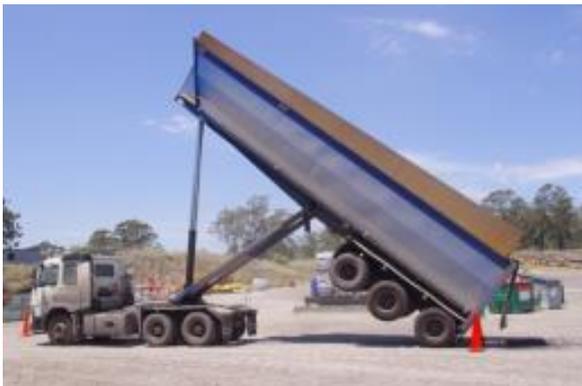
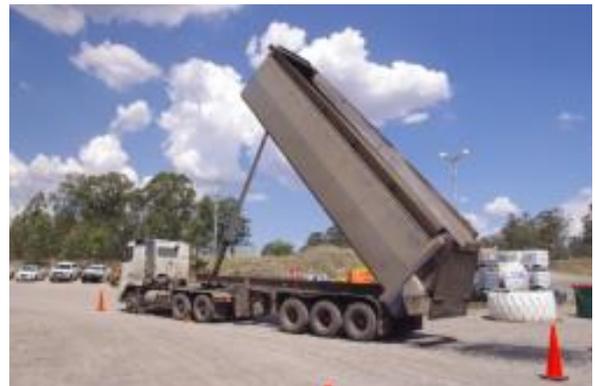
The Muscat trailer being a tri-axle tipper tipped with only the rear axle and last line of tyres staying in contact with the ground whereas the Marlin trailer, being a chassis tipper, tipped with all three axles and tyres staying in contact with the ground.
