Week ending 31 October 2018

This incident summary provides information on reportable incidents and safety advice for the NSW mining industry. To report an incident to the NSW Resources Regulator: phone 1300 814 609 24 hours a day, 7 days a week.

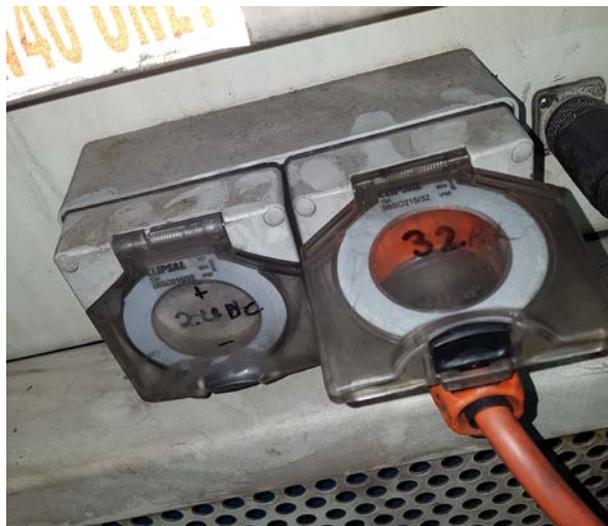
Incident type	Summary	Recommendations to industry
Dangerous incident SinNot-2018/01801	A driller suffered an electric shock. Following electrical trips, area lights were removed from a drill rig on night shift. The day shift driller found a replacement light bar and installed it. The driller went to adjust the lights and suffered an electric shock. An ECG cleared him of any injury. An investigation identified that the light bar had been plugged into the incorrect supply. A 24V DC and 32V AC supply were a common socket and installed next to each other.	Where different voltages are used on equipment/plant they should have unique sockets and plugs to prevent inadvertent use. Mines must have systems in place where plant and equipment is inspected to ensure it is fit for purpose when entering the site. Repairs must only be undertaken by competent tradespeople.

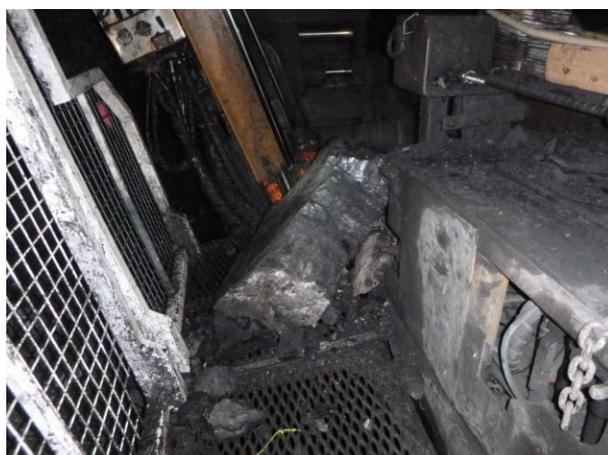
Dangerous incident
SinNot-2018/01798

A worker narrowly avoided injury when he was brushed by falling coal. Some rib spall fell against the rib protection, it then broke and a piece fell over the rib guard.

Rib protection fitted to continuous miners must be designed and operated to match the rib conditions at the mine and forms part of the entire temporary support requirements while installing support.

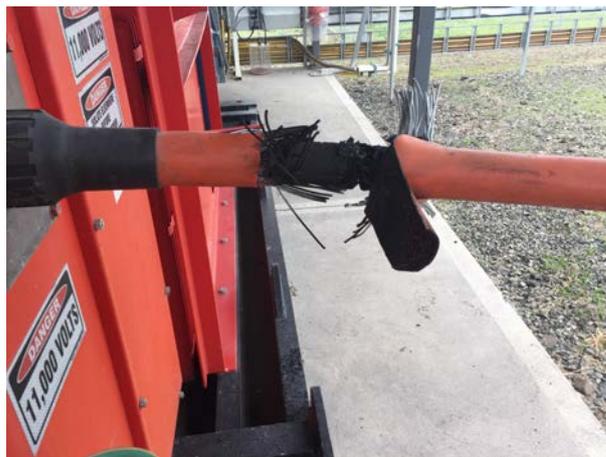
Dangerous incident
SinNot-2018/01793

A live 11kV electrical cable was cut by unknown people at a remote borehole site. This resulted in the safety circuits tripping power to the cable. On investigation, clear signs of arcing/flash could be seen. Other electrical cables were stolen from the site. The incident was reported to police.

Site security of remote areas should be reviewed. Warning signs and stickers should be fitted to equipment that may be live.

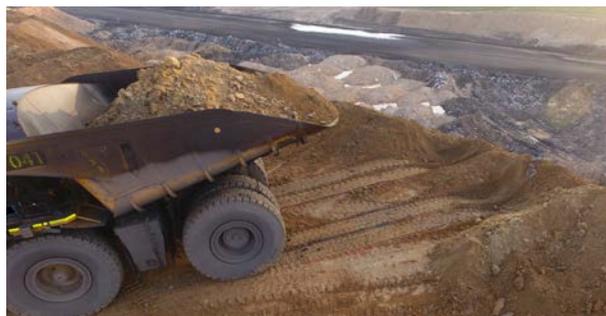
Dangerous incident
SinNot-2018/01790

A dump truck was reversing into a dump face when position 5 and 6 tyres went through a windrow. The short wall was about 10 m high. The operator was not injured. The truck was pulled back onto solid ground about 10 m from the edge.

Dump procedures must specify:

- minimum requirements for windrows
- how operators are required to approach windrows (e.g. square to windrow)
- stopping distances from edges and windrows
- windrow height, considering height increases due to incompetent material being dumped or water pooling under dumps.

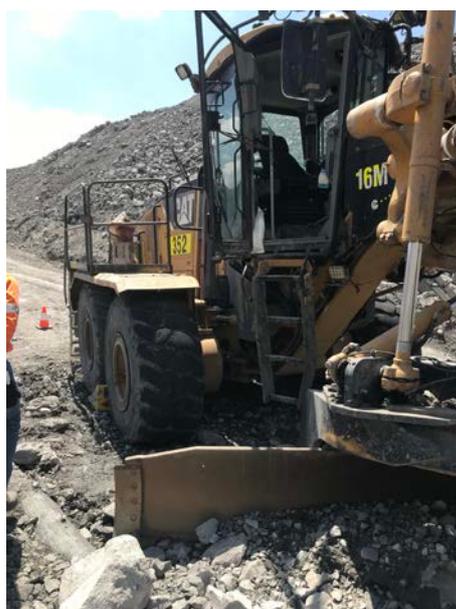
Serious injury
SinNot-2018/01788

A worker suffered lacerations to the face and head while operating a grader in an open cut mine. A drill rig access track was being repaired when a pressurised 355 mm poly pipe was pierced by the blade. The blast of water picked up loose material and rocks and smashed the side window. The mechanism of injury is still being investigated.

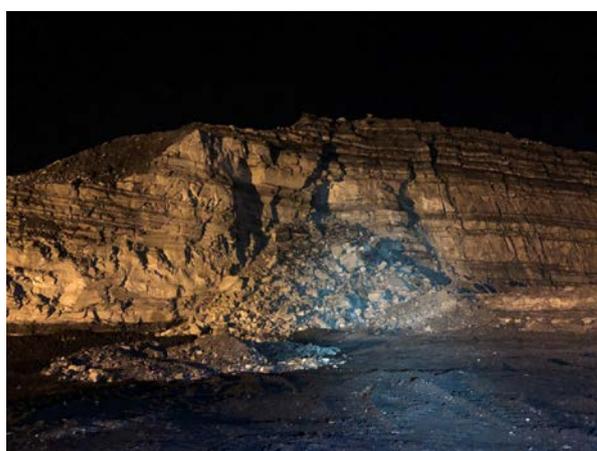
Dangerous incident
SinNot-2018/01773

A highwall (about 22 m) partially collapsed in an open cut coal mine. An excavator and a dozer were working in the area. The operators noticed the highwall start to dribble and moved the machines away before the collapse.

Highwalls must be cleaned back to solid ground to remove material from the wall during excavation.

Highwalls must be inspected regularly, particularly following wet weather events.
