Resources Safety and Health Newsflash

Failure to Give Way at a T-intersection

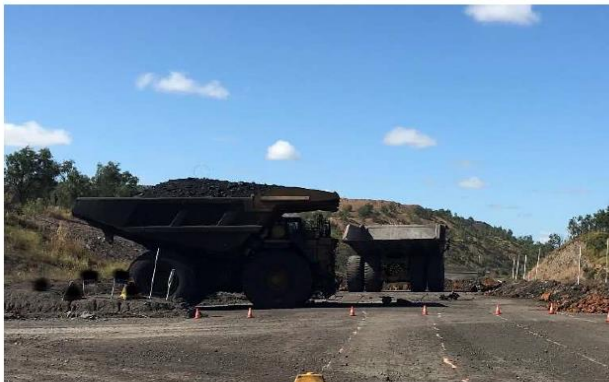
The headboard on the loaded truck would fit beneath the headboard of the empty truck.

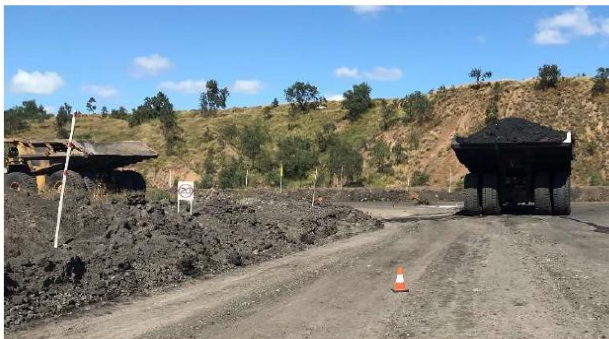
The loaded truck had right of way
