INCIDENT ALERT

LOCATION: AGGREGATE DREDGER
ACTIVITY: ACCESS & EGRESS & WORKING AT HEIGHT
SUB ACTIVITY: N/A

Operator sustains grazed/bruised back from contact with scaffolding -non-treatment injury - BMAPA Alert

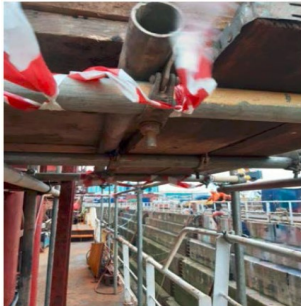
A UK marine aggregate dredger was undergoing its annual dry dock. Scaffolding had been erected in the vicinity of the aft screening tower to facilitate its removal. The scaffolding was erected across the starboard side walkway which restricted the walkway, with the scaffolding platform only being 1.5m above the spillway. The erected scaffolding had red and white hazard tape applied to highlight the low height of the scaffolding and the protruding scaffolding clips whilst waiting on delivery of protective foam.

The IP transited this walkway for general access to the engine room and in doing so, whilst crouched down, impacted his back on the protruding scaffolding clips. This caused a small abrasion and bruise on the left side under the shoulder.

It has been identified that there was inattention to immediate surroundings as the scaffolding was highlighted with hazard tape.

- Staff to discuss the importance of paying attention to their immediate surroundings and the importance of making informed decisions where normal access routes may be restricted during maintenance periods.
- Ensure scaffolding has been fully completed, including foam protection fitted before signed off and used as a thoroughfare.
