# NZ Safety Alert

4 June 2021

## Contact between excavator and DT

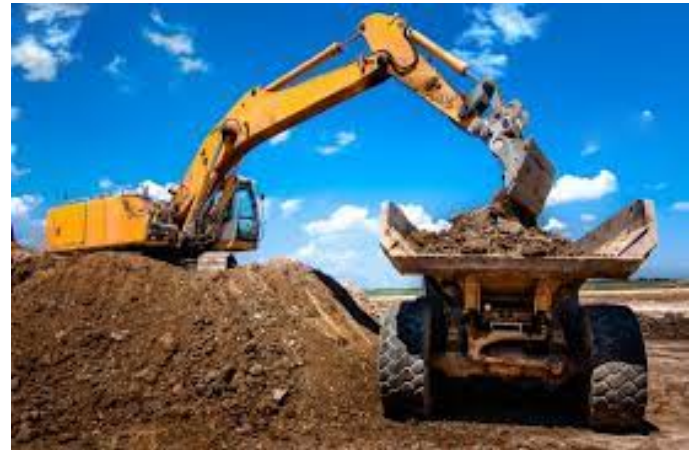
An excavator had loaded two bucket loads onto a dump truck as the morning sun was rising.

As the operator swung the bucket with the third load, he lost vision of the bucket and the excavator stick, due to the sun rise.

The excavator extended the stick, however not high enough to clear the truck tray resulting in contact with the tray of the dump truck.

The contact caused the truck operator to hit their head on the side of the cab which resulted in them being taken to hospital for observation.

1. If mobile equipment operators experience any loss of visibility, including sunstrike, they stop operating and review the task and positioning of the equipment.
2. You review the suitability of seatbelts in mobile equipment and seatbelt clips, or other devices used to inhibit seatbelt movement.
3. All operators are trained and assessed as competent to safely operate mobile equipment.
