Another worker killed in gravity take-up

14 September 2018

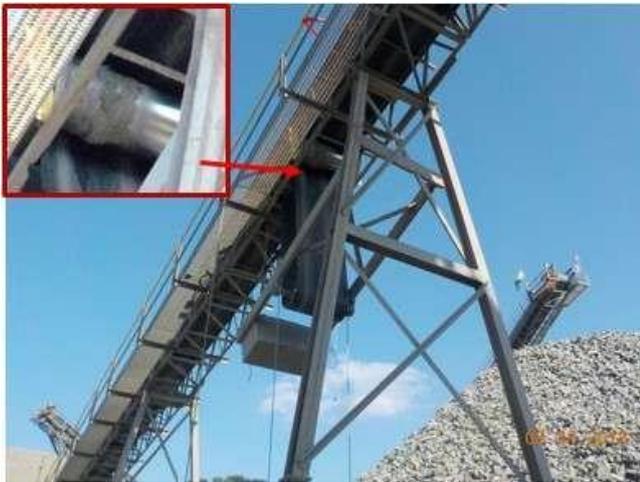
A worker was fatally injured on 22 August in the USA, when he was caught in a take-up roller on a conveyor (refer attached alert).

In both these incidents the conveyor was operating at the time of the incident and guards were not fitted adjacent to the gravity tower take-up rollers and grease points.

We recommend that all sites review tasks that involve maintenance on conveyors while the conveyors are running including greasing, belt tracking, and inspection. You need to ensure that:

- **Suitable guards are fitted on or adjacent to moving or rotating pieces of equipment to prevent workers coming into contact with the piece of equipment**
- **Workers are fully trained and assessed as competent to conduct activities on plant**
- **Tracking adjustors and grease lines are extended or adjusted so that they are outside of guards and so that guards do not have to be removed to conduct maintenance**
- **All maintenance tasks are adequately risk assessed, and controls put in place, to ensure no risk of harm to workers.**
