SAFETY ALERT

Pneumatic air tool fitting fails

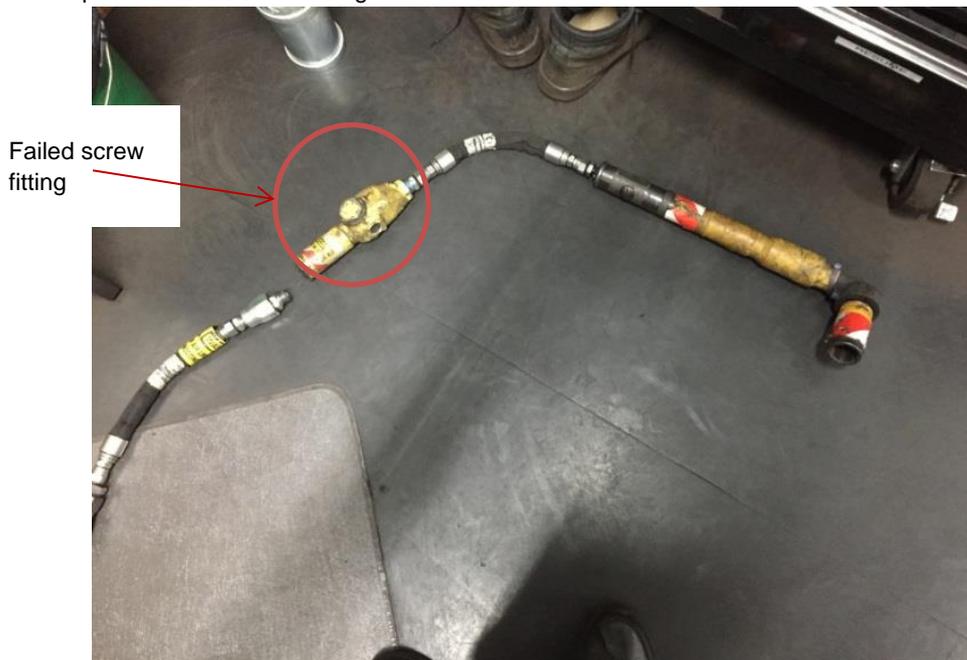
The worker was tensioning recovery mesh on a longwall in preparation for a change-out using a hired pneumatic ratchet on a boat winch. During this process the pneumatic ratchet came apart at the location of a new swivel fitting and released compressed air. The threaded fitting had become loose and unscrewed at the swivel fitting.

Figure 1 – photo of failed screw fitting

The swivel fitting was installed on the pneumatic tool, however it was found that there was no thread lock applied to the screw end of the swivel.

Investigations by the original equipment manufacturer at their workshop found that three of the nine ratchets used had no thread lock at the swivel and would undo easily. The remaining six were difficult to undo and had a thread lock.

- a) installing a swivel fitting to assist in preventing the unwinding of screwed fittings during use and tool changes
- b) using a mechanism to prevent the unscrewing of screw fittings, such as a thread lock compound, tab washers, grub screws or pins
- c) using automated hose rupture detection air shut-off valves.
