Serious injury

Incident date: 23 July 2018

Event: Serious injury at an open cut coal mine

Location: Bulga Surface Operations, Singleton NSW

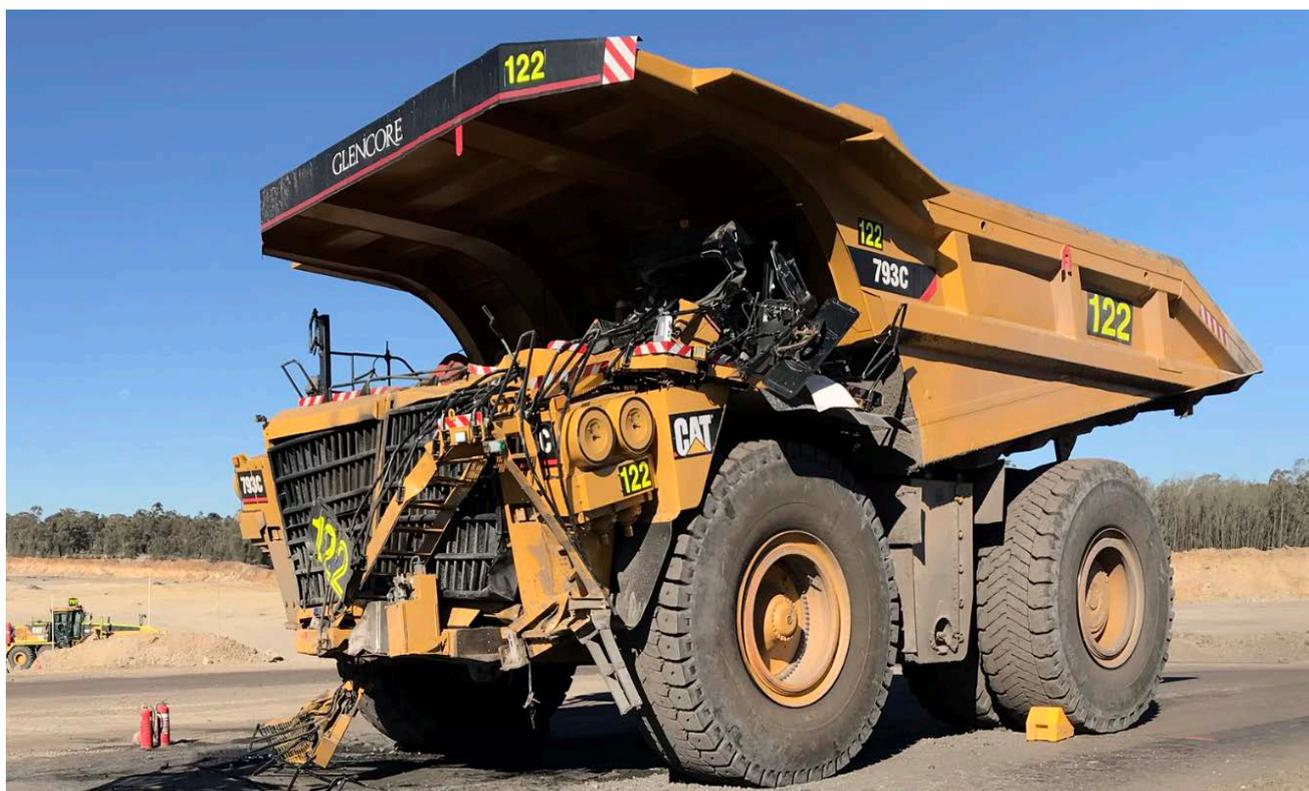
Photograph 1: Damaged nose of haul truck. Photograph by Major Investigation Unit.

The worker failed to stop, which caused a nose-to-rear collision with the second unladen haul truck. The front of the worker's haul truck impacted with the rear edge of the tray of the second truck, crushing the operator's cabin and trapping the worker inside.

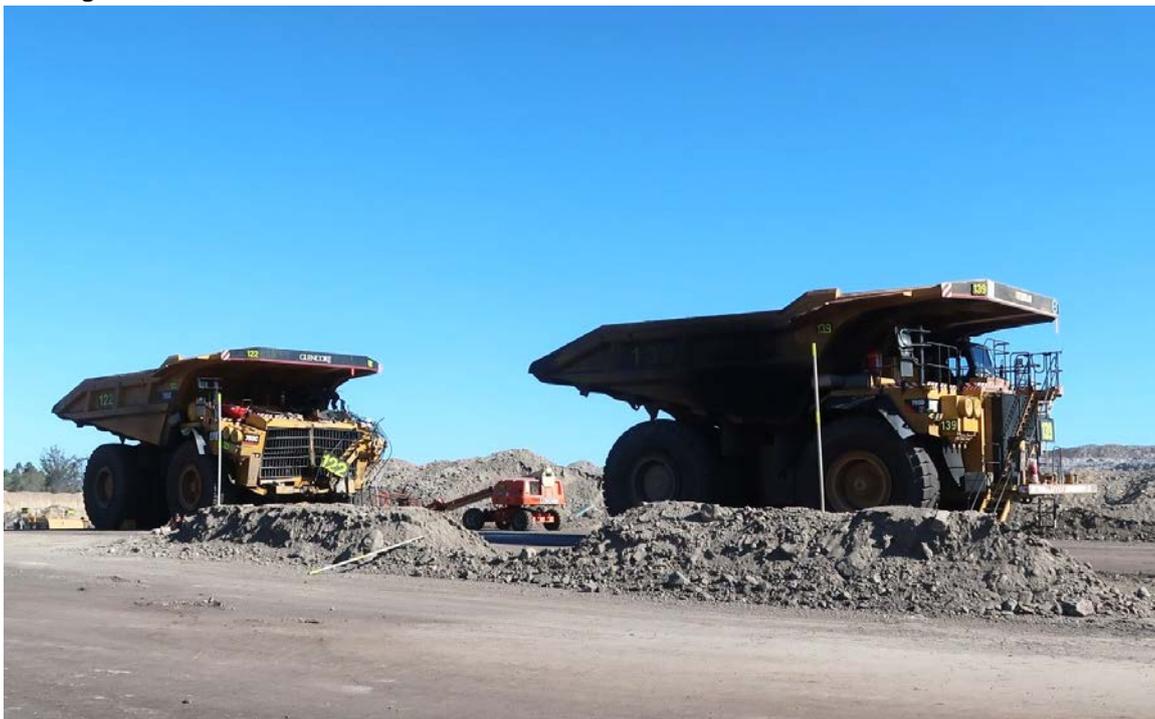
Photograph 2: Nose-to-tail collision of two dump truck showing height of truck tray and cabin. Photograph by Major Investigation Unit.

At 3.45 am on 23 July 2018, a labour-hire worker, aged 28, was operating an unladen haul truck at Bulga Surface Operations. The worker drove along a haul road toward a second 223-tonne rear dump truck that was stopped on the haul road to give way to other vehicles entering the haul road.
