## INCIDENT ALERT

**LOCATION:** CONCRETE PRODUCTS  
**ACTIVITY:** GUARDING AND ISOLATION  
**SUB ACTIVITY:** NO SUB ACTIVITY AVAILABLE

**ALERT STATUS:** Normal  
**DATE ISSUED:** 03/08/2018 17:04:20  
**INCIDENT No:** 01493

**Failure of wire after stressing**

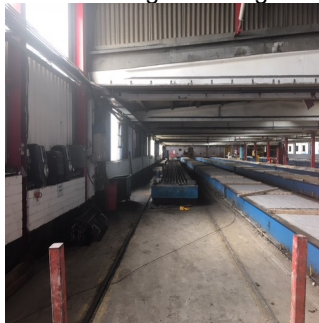
During a routine stressing procedure using 5 mm wire for the production of wet cast T-beams, a wire snapped in the centre of the bed seconds after the bed had been stressed and the pins inserted, causing an unplanned release.

The two broken parts traversed to either end of the bed travelling underneath the restraining chains, exited the end of the bed and continued to travel some distance down the workshop.

The wire was quarantined and both ends of the broken wire sent away for independent metallurgical examination. The conclusion was that the wire had been welded resulting in decarburisation.
