## Significant Incident Report No. 237

**Subject:** Failure of crane head sheave

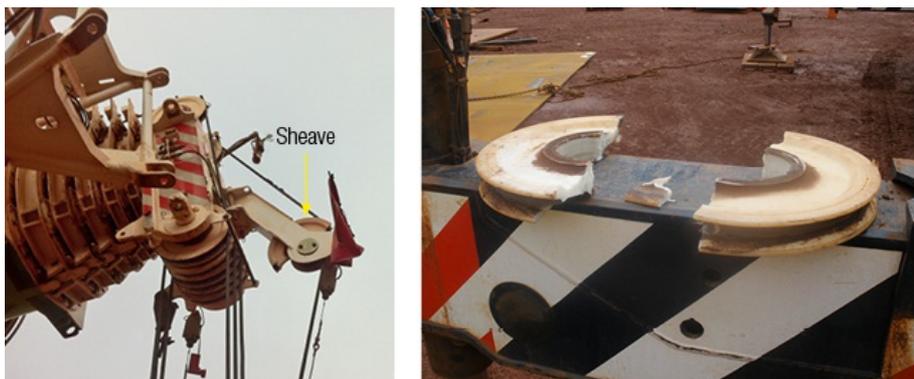
In July 2014, a mobile crane at a mine site was being used to unload a truck. After a daily pre-start inspection, the crane took the weight and lifted the load. As the crane started to slew, the nylon head sheave (rooster sheave) weighing about two kilograms, catastrophically failed. Part of the sheave fell around 10 metres to the ground, narrowly missing a rigger working in the exclusion zone below.

When the sheave was inspected later, it appeared to have been damaged prior to the lift.

Damage to nylon head sheave. Right. Half of the failed sheave for the auxiliary hook remained in place. Left. Sheave sections recovered after the incident.

- The damaged head sheave failed and fell from height during a lift.

- Damage to the head sheave was not identified during the daily pre-start inspection of the crane by workers.

- Check all sheaves for alignment, damage (e.g. cracking), wear, mobility and extreme soiling before starting a crane operation.

- Operate cranes in accordance with the OEM's specifications, including avoiding side loading on sheaves.
- Maintain sheave blocks in accordance with the OEM's specifications.
- Double-blocking should not be practiced, including when moving or packing the crane. A spotter should be available to direct the crane operator where there is the potential for double-blocking.

- A hoist-limit switch or hoist-limit alarm should be fitted to mobile cranes to stop the winch or to warn the operator before the hook block or headache ball makes contact with the head sheave(s).
