DANGEROUS INCIDENT

Shot firing incident damages vehicles

Event: Flyrock damages vehicles during blasting at quarry

Location: Albury Quarry, Albury NSW

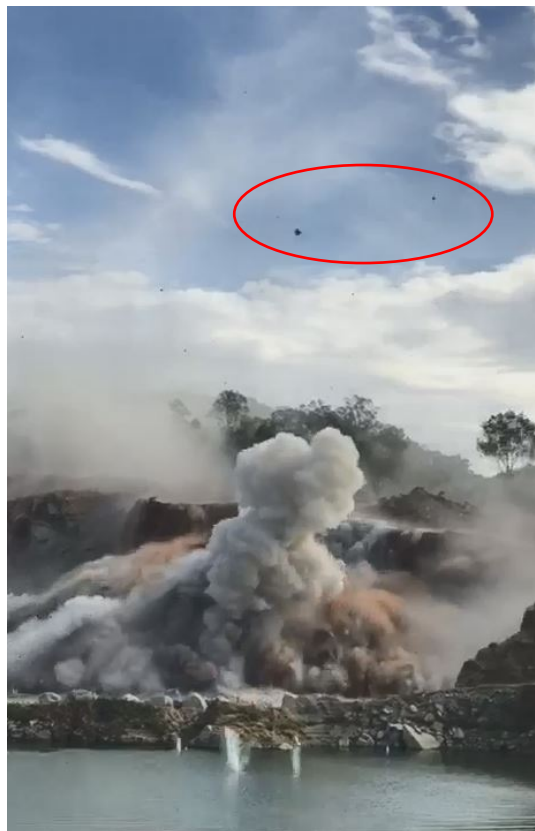
Photograph 1: Flyrock moving through the air following the blast. Photograph obtained from video footage supplied to the NSW Resources Regulator.

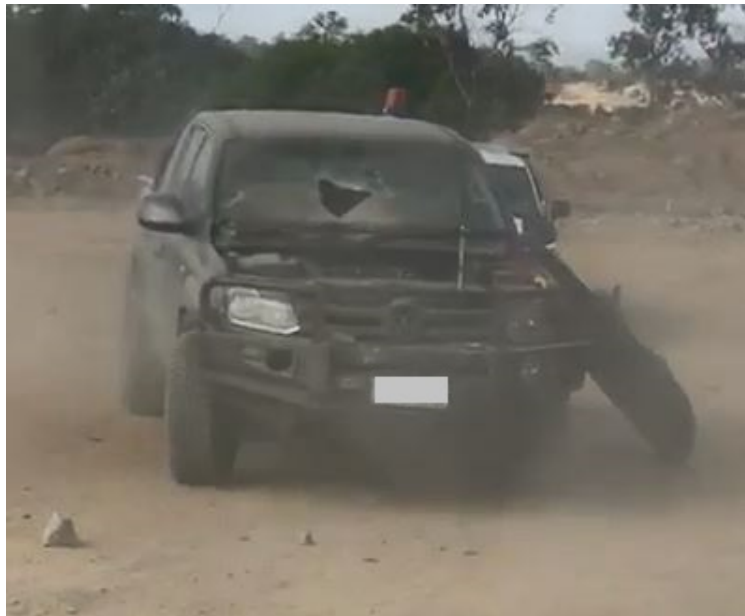
Preliminary enquiries have identified that mine workers and members of the public were between 300 and 340 metres from the blast location. Flyrock from the blast travelled through the air and damaged three light vehicles parked a short distance away from people. Seven people were at risk of being struck by flyrock.

Photograph 2: One of the light vehicles damaged by flyrock. Photograph obtained from video footage supplied to the NSW Resources Regulator.

Mine operators must ensure that appropriate information, instruction and supervision is provided to workers and members of the public in relation to exclusion zone requirements set out in blast control plans.

Mine operators are reminded that appropriate systems must be in place to review and audit the explosives control plan and blasting work practices to ensure that exclusion zone requirements are enforced. No persons should remain within exclusion zones during blasting activities.
