Elastic springback in plates on equipment

Mines safety bulletin no. 172

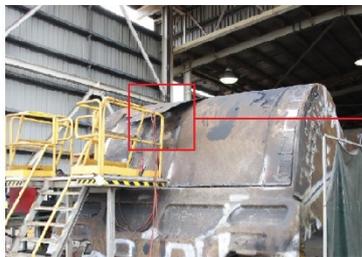
Fig. 1B – Bucket in workshop

The main bucket structure is made of structural steel and covered with internal and external wear liner plates. The liner plates are consumables and depending on their condition are removed and replaced from time to time.

Long wear plates were fitted around most of the outer surface of the bucket involved in the incident. This was a modification of the original equipment manufacturer's design where multiple smaller plates were used.

The original design had much less springback potential because using several wear plates instead of one large one will reduce the amount of stored energy that has to be controlled at any one time during removal. (Compare Fig. 3 with Fig. 1B)

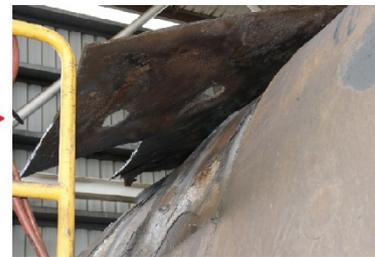
Fig. 1C – Sprung plate

A boilermaker was using an air carbon arc gouging process to remove an external wear plate from an excavator bucket. The plate unexpectedly sprang up approximately 1200 mm. About midway in this upward movement, it struck the boilermaker on his forehead, fatally injuring him.

For the plate involved in this incident, indentation was the primary contributor to elastic springback.
