## Significant Incident Report No. 261

**Subject:** Face shovel operator crushed between ladder and handrail – fatal accident

**Date:** 07 May 2018

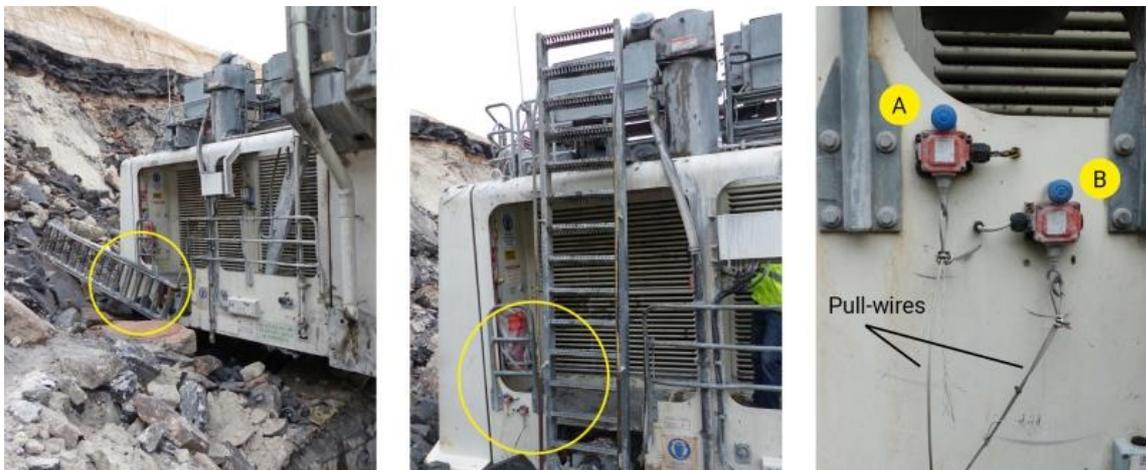
The pit face had collapsed, and overburden material had rilled against the side and rear of the shovel. This appears to have put tension on the pull-wire of the emergency shutdown switch, which is located next to the emergency access ladder pull-wire switch.

The operator was found on the shovel platform, crushed between the handrail above the emergency switches and the hydraulic ladder, which had rotated down. This resulted in fatal injuries.

Circles indicate where the accident happened, showing the ladder in the final (left) and upright (middle) positions with the handrail, platform and emergency shutdown (A) and ladder (B) switches (close-up, right).

- The hydraulic ladder was activated and rotated anti-clockwise while the operator was in the line-of-fire.

- Conduct an audit of shovels and excavators on site to identify all configurations of actuated access ladders and stairways that could present a crush hazard to workers accessing emergency switches.

- Conduct a risk assessment of these potential crush hazards and implement appropriate controls (e.g. safe positioning of switches, clearly labelling all switches and switch positions, providing adequate lighting for all tasks).
- Review standard operating procedures for the operation of shovels and excavators to confirm they include operation and reset of emergency switches.
- Train those using and accessing shovels and excavators in the reviewed standard operating procedures.
