Preventing fires on mobile plant: responding to safety alerts

This safety bulletin provides safety advice for the NSW mining industry.

Issue

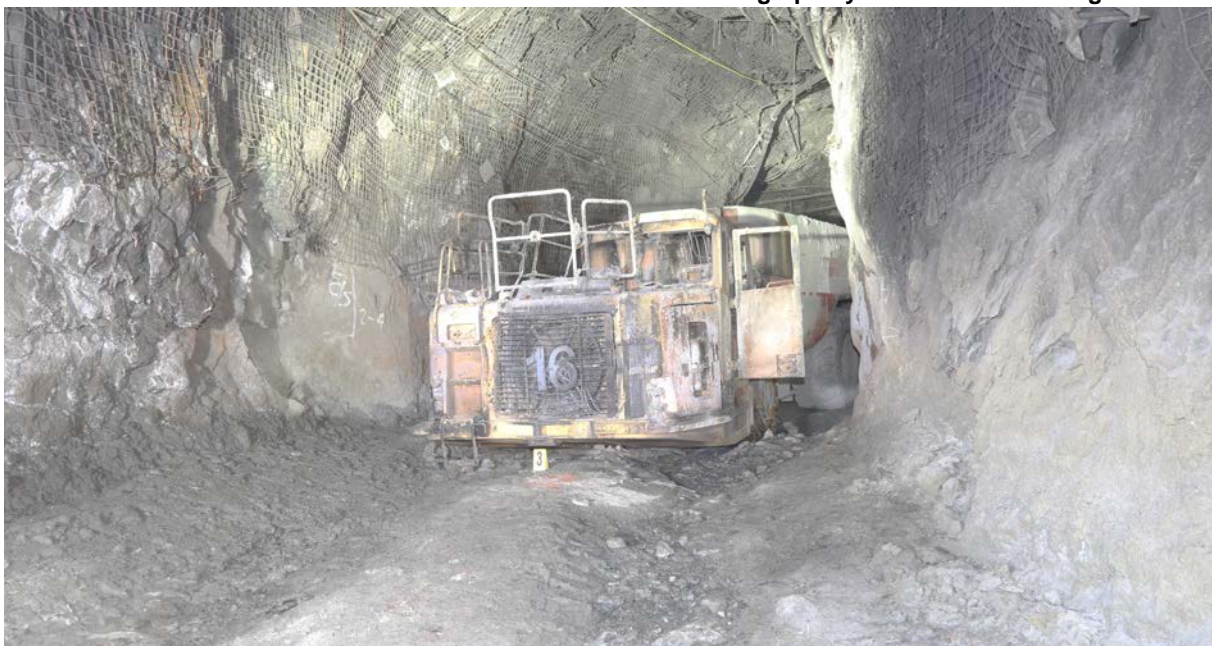
Investigations into one serious fire recently identified that a safety bulletin requiring immediate attention to mitigate a known fire risk had not been implemented on a truck at the underground metalliferous mine some six months after it was issued. The machine subsequently caught fire and was destroyed. The cause of the fire was under investigation at the time of writing and although it may not be related to the topic of the safety bulletin, the continued operation of a machine for six months with a known fire risk is unacceptable.

Photo 1: Burned out truck in metalliferous mine decline. Photograph by NSW Resources Regulator.

After an incident in which a 60 tonne haul truck was destroyed by fire, a review of the truck and of safety bulletins from OEMs was undertaken by the Resources Regulator. This review identified multiple potential causes of the fire or contributing causes including:

- cooler fan motor hoses not upgraded
- coolant hose rerouting not completed
- clogged exhaust pipe
- improvements to fuel line routing and support not completed
- heat shields potentially damaging oil lines
- firewall and hose protection improvements not completed
- additional cover not added to right hand side fuel tank
- improved fuel line material not used
- damaged fuel tank
- overpressure in fuel tank.

To reduce the risk of mobile plant fires to as low as is reasonably practicable, mine operators should:

- ensure they have access to OEM and industry safety alerts and safety bulletins
- act on those alerts and bulletins and liaise with the OEM to update their mobile plant with the latest improvements and modifications, either immediately or within the timeframe specified
- include the maintenance of those improvements and modifications in their safety management system.
