Linishing wheel makes contact with worker

Description – What Happened?

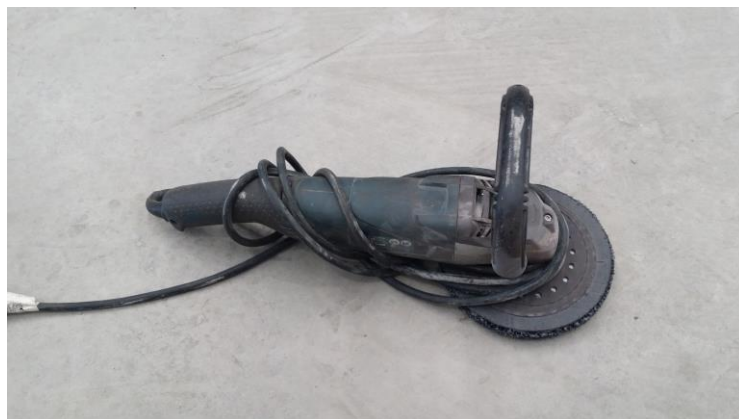
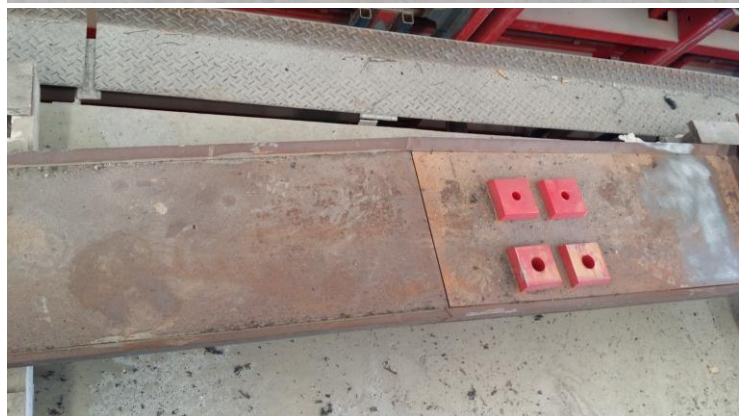
A worker was removing rust from the corner of a steel concrete mould using a five-inch grinder and a linishing wheel.

The linishing wheel grabbed during operation, causing the grinder to flick up and make contact with the worker's left forearm, causing a laceration requiring medical treatment.

- Task planning did not consider specific hazards of using a linishing wheel near the corners of a steel mould section.
- The ergonomics of performing the task on the ground forced the worker to hold the tool in an awkward position. This exposed the worker to unnecessary hazards.
- The grinder in use had a lockable trigger – that is, a paddle switch that could be locked on. The grinder continued to operate even after it flicked out of the worker's control.
- Worker had sleeves rolled up at the time of the incident

- All grinders on site are to have non-lockable triggers
- Where possible, work should take place on trestles or work benches as opposed to on the ground.
- Reinforce the importance of wearing PPE correctly
- Better task planning to ensure correct ergonomics for tool use
