CAUSAL INVESTIGATION

# Catastrophic engine failure in an underground coal mine

Title: Causal investigation: Catastrophic engine failure in underground coal mine

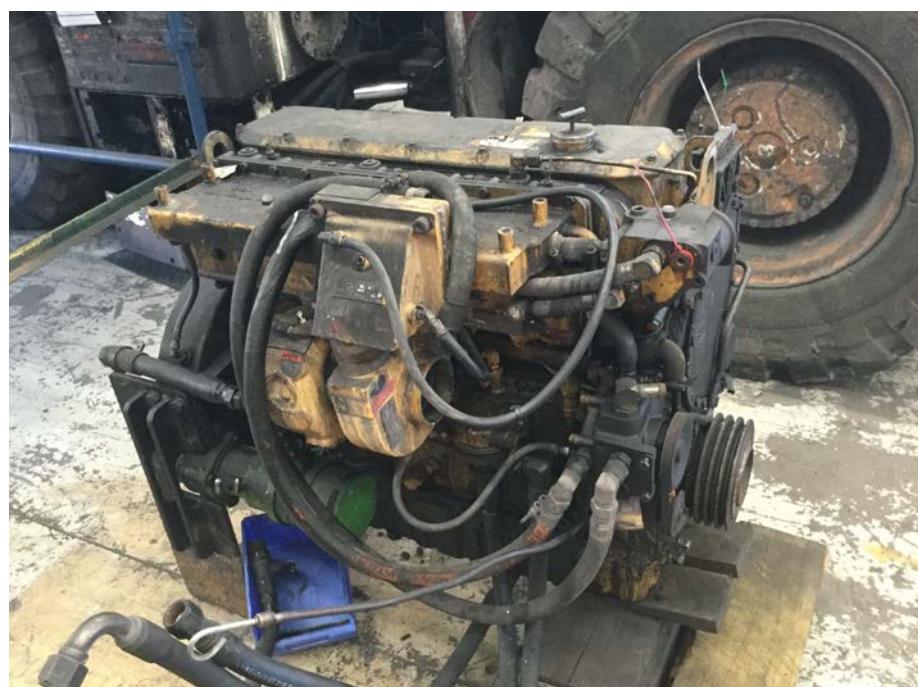
**Figure 2: Engine from FBL10.**

At the third visit to WesTrac on 4 September 2017, the causal investigation team watched the disassembly of the FBL10 engine at WesTrac. Before the arrival of the investigation team, WesTrac workshop personnel had carefully removed the engine covers and ancillary components and placed the engine block on a stand ready for disassembly. During this visit, the exhaust valve was found to have a bent valve stem. This was caused by contact between the valve head and the piston as a result of the No 6 conrod and bearing failure.

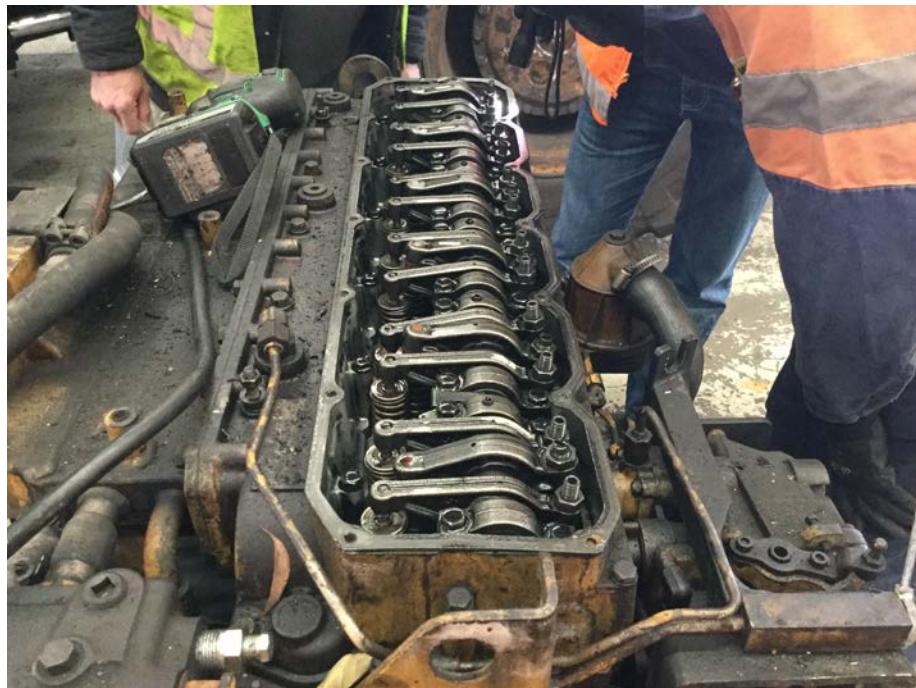
Figure 3: Rocker cover removed to access valves and fuel injectors.
