# **Investigation report**

Report into the death of Stephen Norman  
at the Rix's Creek Coal Mine, Singleton, NSW,  
on 13 December 2016

First published: November 2018

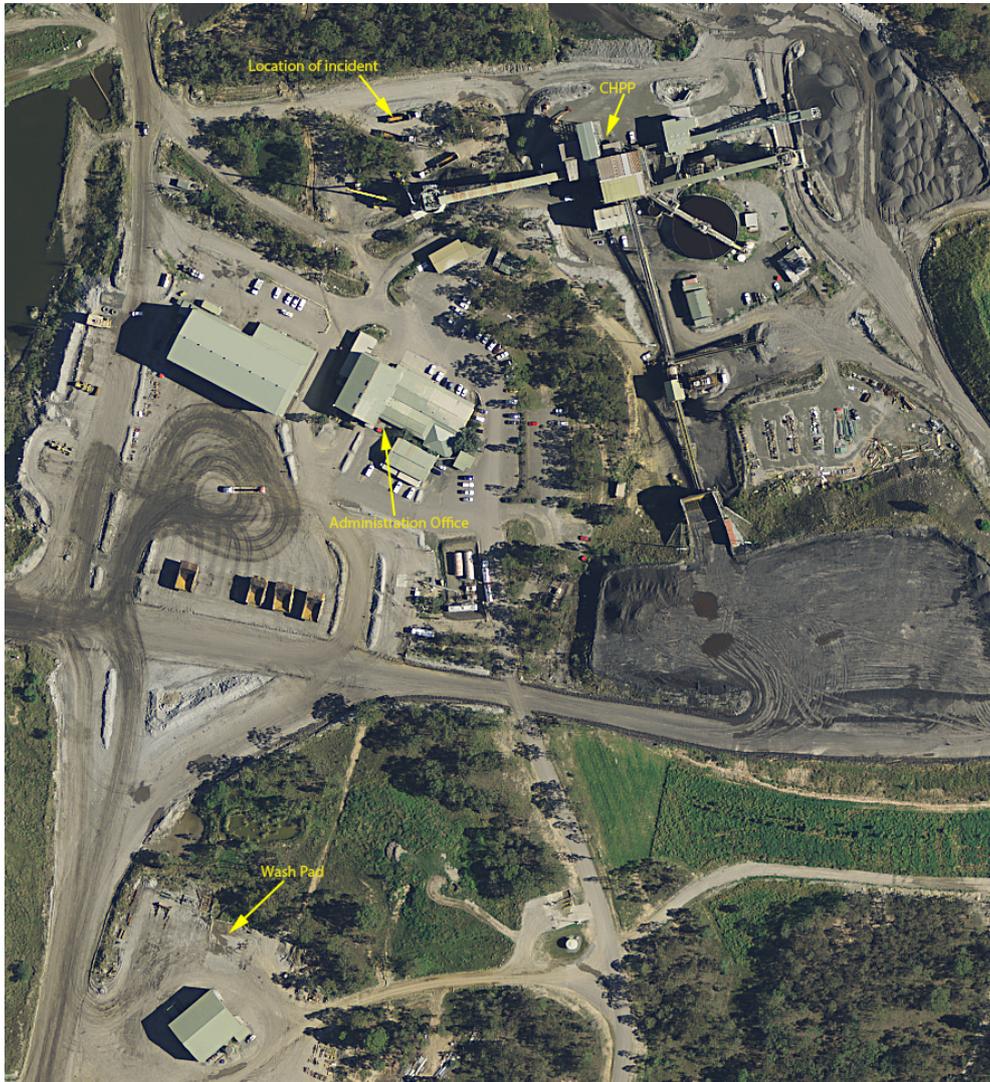
Figure 3 Location of the incident.

The incident occurred within the coal lease on an area near the coal handling preparation plant (CHPP) as shown in figure 3.
