Fire on explosive charge vehicle while at a charged face

Mines safety alert no. 369 | 04 December 2019 | Version 1

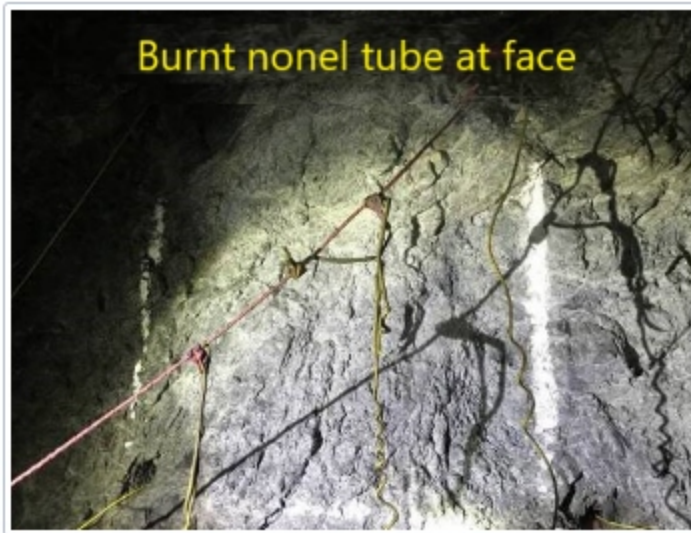
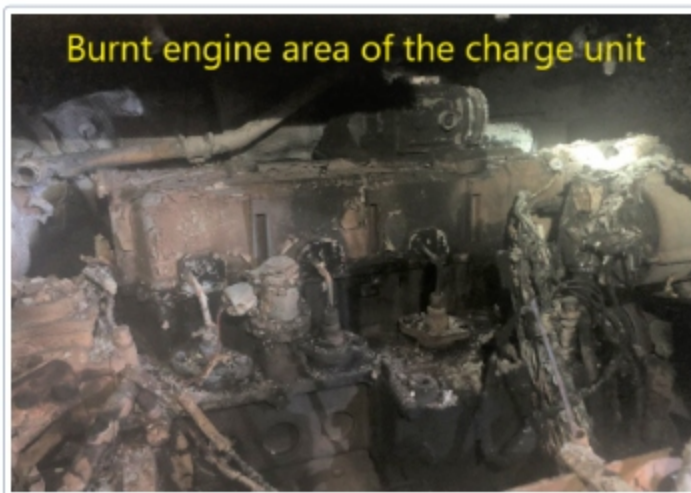
When trying to move a charge unit from a heading after charging the face, the charge crew found the machine unserviceable. An injector unit pump was found protruding about 1cm from the engine block of the vehicle as a result of broken clamp down bolts. Maintenance personnel re-installed the injector unit pump with new bolts and cleaned up the fuel which had spilt in the engine bay.

Incorrect bolts had been used to secure the injector pumps, which subsequently failed. When maintenance personnel replaced the broken bolts and reinstalled the injector unit pump into the engine block, the fuel rack and clevis on the injector unit pump were not in the correct position for installation. This caused the clevis to be misaligned, jamming the fuel rack in the full fuel position.

1. With assistance from the OEM, consider installing engineering solutions to mobile equipment which work in conjunction with the E-stop to stop the engine in an emergency, such as:

- Stopping fuel to the engine with a fuel shut off valve on the fuel supply, or
- Stopping air supply to the engine with an air shutdown flap installed to the air intake system.

2. OEM or OEM equivalent parts (including bolts and fasteners) should be used when conducting repairs and maintenance on critical or safety systems.
3. The OEM instructions should be followed when conducting repairs that are unfamiliar, complex or to critical systems (such as the fuel system).
4. Audit fuel systems on mobile plant for damage, fuel leaks or residual fire hazards.
