NZ Safety Alert

November 2019

Dangerous access to crusher

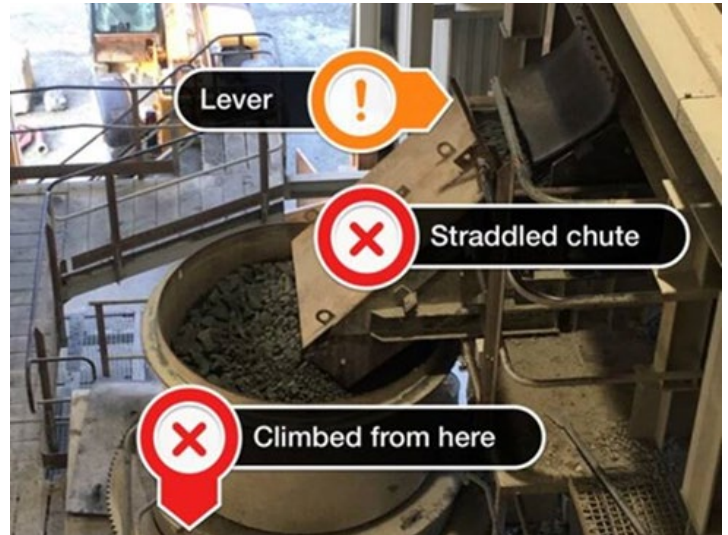
A labour hire worker was trying to shut the bin door over a crusher from the walkway around the crusher. He experienced difficulty and called for help from the contract engineer via the RT.

The contract engineer climbed over the handrail and stood on the brackets supporting the chute, while straddling the chute to access the lever to close the bin door. The crusher was operating at the time.

1. Fall hazards such as poor access and areas where workers can fall from height are identified in risk assessments.
2. Adequate and effective controls are in place to ensure no-one is exposed to the fall hazards identified including appropriate exclusion zones and no-go areas.
3. Any requirement to leave established access ways or platforms (including crossing handrails or any other barriers) to perform maintenance or any other activities, are risk assessed and where possible eliminated.
4. All activities are adequately supervised, including workplace inspections and task observations.
