Incidents – 3 Machinery overturning in 1 month

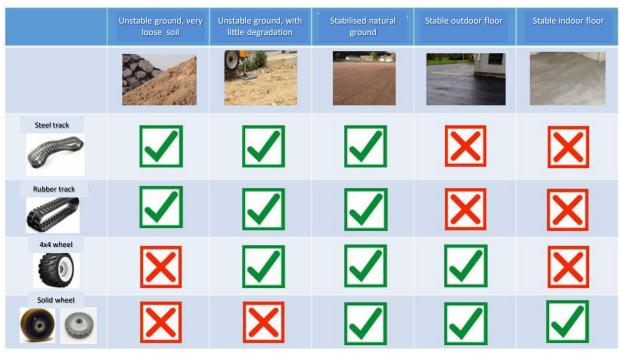
- Adequacy between the ground bearing capacity and the machinery (nature of the ground, distribution plates/mats, under-pinning, allowable soil bearing capacity, etc.)
- Focus on unsafe machinery travel situations:
 - configuration of the machinery for moving around,
 - centre of gravity identification,
 - counterweights positioning,
 - maximum permitted slope and direction of machinery when climbing slope,
 - travelling across an obstacle,
 - traffic along edge of slope or top of wall,
 - travelling across a hole, etc.

Analyse whether the machinery is designed to be used for the work area: including conditions for machinery access and movement/travel
