Fixed plant and mobile equipment fires on surface coal mines

Mines safety bulletin no. 158 | 21 November 2016 | Version 1

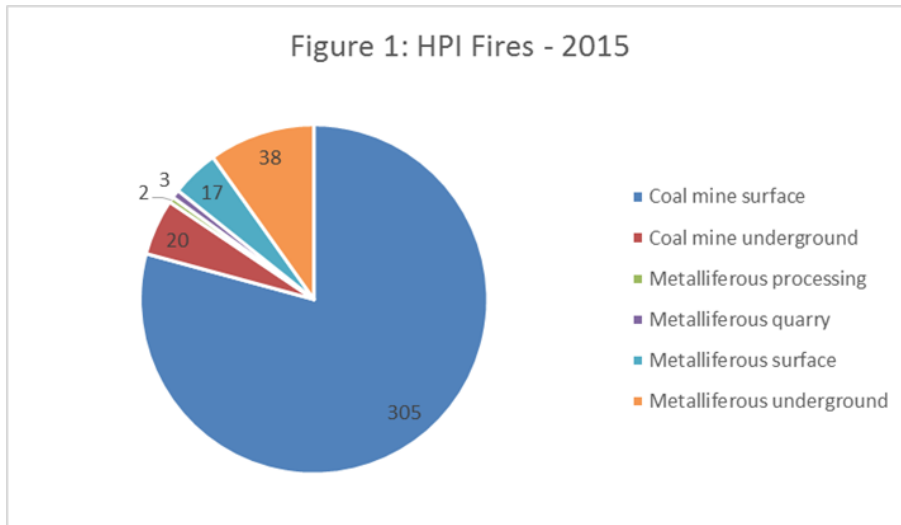
During the 2015 calendar year, 2091 HPIs were reported to the Queensland Mines Inspectorate. Of these 385 were reported as fires (see Figure 1), with 305 fires reported from surface coal mines and over 90% of these fires involved fixed plant and mobile equipment (refer Figure 2 and Figure 3).
