Significant Incident Report No. 253

Subject: Injured worker not discovered and treated for extended period

Date: 27 June 2017

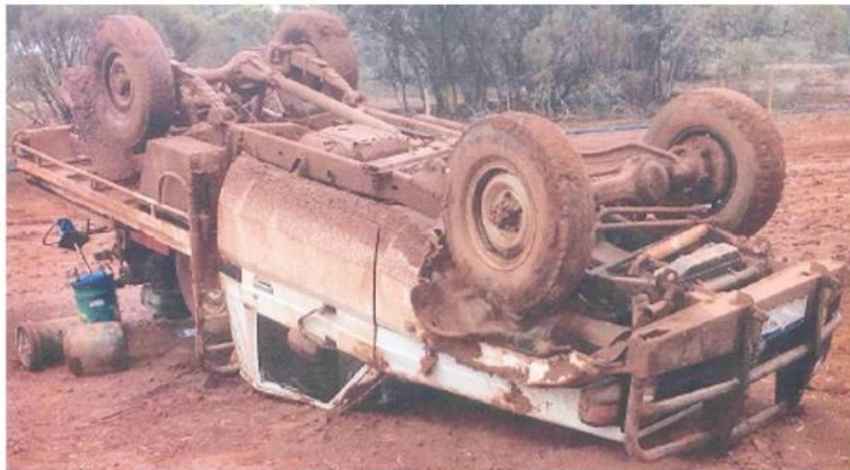
In January 2017, the driver of a service vehicle was travelling along a haul road to a satellite pit to deliver fuel. The area had experienced overnight rain, and the driver lost control of the loaded vehicle. The light vehicle mounted a verge and rolled onto its roof.

Overturned service vehicle.

The vehicle's radio aerial was damaged in the rollover and the driver, who was unable to walk due to serious injuries, could not raise an emergency call. Use of the haul road had been restricted because of conditions, he was discovered two and a half hours later by a passing worker who raised the alarm. The driver's absence had gone unnoticed by his work colleagues.

- The vehicle rolled.
- The driver was unable to call for assistance due to the damaged radio aerial and absence of a back-up communication system.

- The ambulance was unavailable and the back-up ambulance had to be jump started.
- The emergency rescue team were unfamiliar with the site and did not know the way to the incident location.
- The vehicle was fitted with mismatched tyres, not driven to conditions and overturned on a section of road with excessive camber that was not sheeted with gravel.

- Establish and review procedures to plan and monitor safe travel during work, including communication and emergency response.

- Confirm secondary communications devices or systems are available to workers when travelling in case of loss of primary communication system.
- Instruct and train workers in safe travel procedures and use of safety equipment and communication devices.
- Review vehicle movements to avoid unnecessary travel when weather is likely to adversely affect road conditions.

- Provide alternative arrangements or back-up emergency equipment should primary emergency vehicles be unavailable.
- Familiarise emergency responders with all areas of the operation, the application of alternate arrangements, and use of back-up emergency equipment.
