SA17-07, June 2017

Non-compliant gas monitors

This safety alert provides information and advice about a gas monitor that is in use with a modification that is not compliant with the design registration. This advice is intended for the NSW mining and extractives industry.

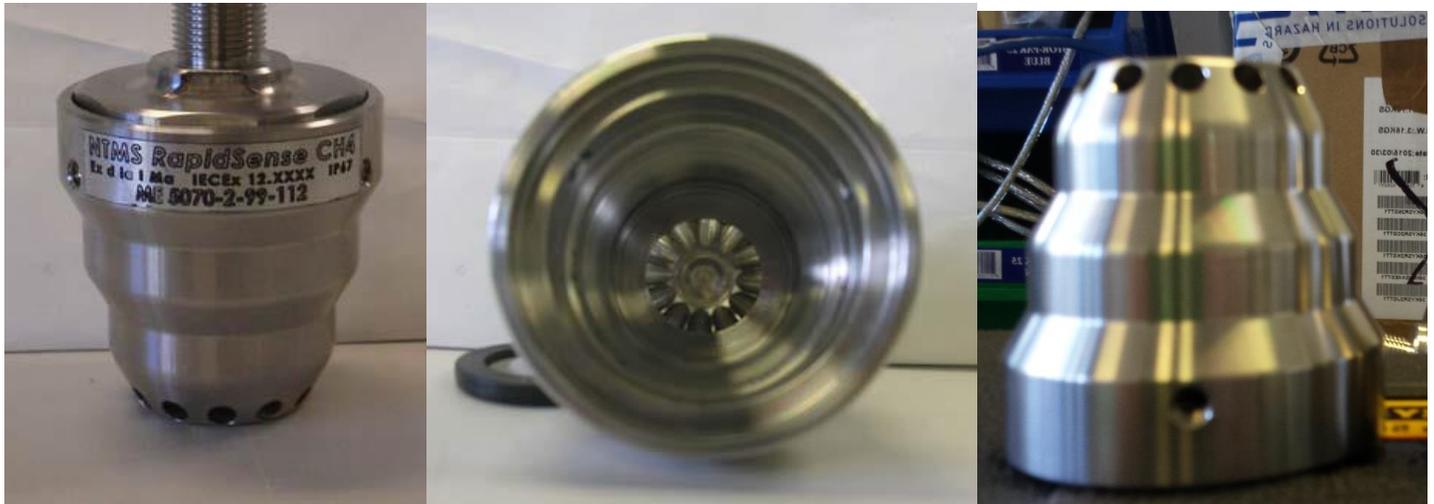
Figure 1: design registered plant

The original design registered housing has 12 gas entry holes, drilled at an angle, providing a comparatively short gas path to the inlet of the sensing element shown in Figure 1.

- Plant fitted with Nautitech RapidSense Exia methane detection systems should be inspected and verified to ensure that the housing covering the detector module conforms to the design registration.
- Non-compliant plant should not be supplied, commissioned or used.
- You should contact the manufacturer and/or supplier to obtain any necessary additional information, including specific advice on how to identify non-compliant plant and the performance of the plant.

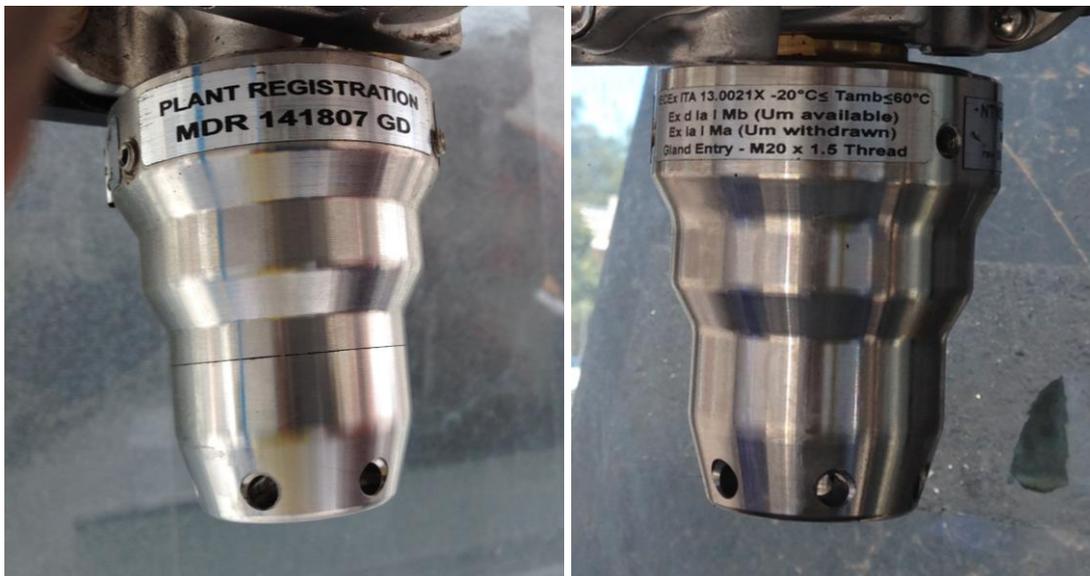
Figure 2: modified plant

The differences between the registered housing and the non-compliant housing are visible due to changes in the physical construction of the unit. Refer to photos below to assist with identifying the compliant and non-compliant housing units.

The modified housing (shown in figure 2 below) has six outside gas entry holes and a centre hole with six gas entry holes to the interior. Note also that the modified housing is taller.
