Tailgate falls off trailer

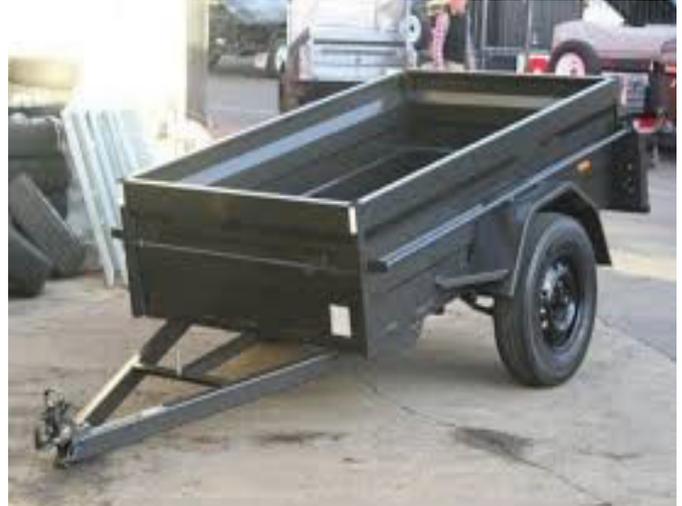
A quarry fitter was towing a trailer on a public road, when the tailgate worked itself free and dropped onto the road bouncing into the path of an oncoming car. The car narrowly missed the trailer, nobody was injured, and there was no damage no damage.

The tailgate had been removed several years earlier and a canopy put on the trailer instead. Recently the canopy was taken off and the tailgate replaced onto the trailer. Different latches were used which enabled the tailgate to work free and fall onto the road.

1. When plant is modified, only fit-for-purpose, original equipment manufacturer (OEM) recommended parts are used. In this case the original latches have now been put back on the trailer.
2. Fall hazards such as slope stability, unsecured tools and equipment, screens etc., trip hazards and areas where workers can fall from height are identified in risk assessments.
3. Adequate and effective controls are in place to ensure no-one is exposed to the fall hazards identified. This may include safety chains on tailgates or other equipment.
4. Plant maintenance checks include all mobile equipment including trailers, bobcats, cranes or other ancillary equipment.
