# NZ Safety Alert

22 May 2020

## Failure to isolate hydraulics

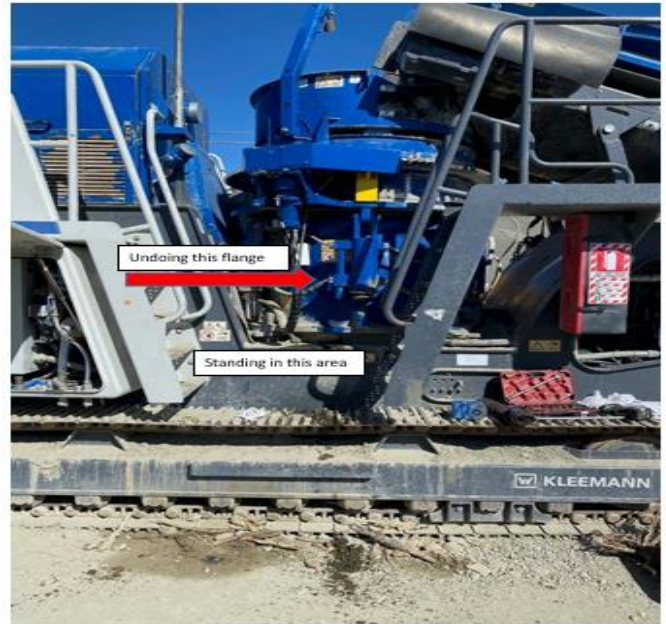
Following a break down, a contract maintenance worker was called to inspect a broken ram that adjusts the crusher cavity on a mobile crusher.

After a discussion with the site foreman, the decision was made to remove the ram and return it to the contractor's workshop for further assessment and repair. As the ram was removed, hydraulic oil squirted out under pressure from the flange of the hydraulic hose into the face of one of the contractors and underneath his safety glasses.

1. All energy sources, including electricity, hydraulic fluid, compressed air, stalled loaded conveyors, etc. are isolated prior to commencing any work on plant.
2. Lock-out (isolation) procedures include a test to ensure all sources of energy have been released or isolated prior to commencing work.
3. All workers are trained and regularly assessed as competent in isolation procedures.
4. All activities are adequately supervised, including workplace inspections and task observations.
