NZ Safety Alert

29 May 2020

Fatal loss of control of vehicle

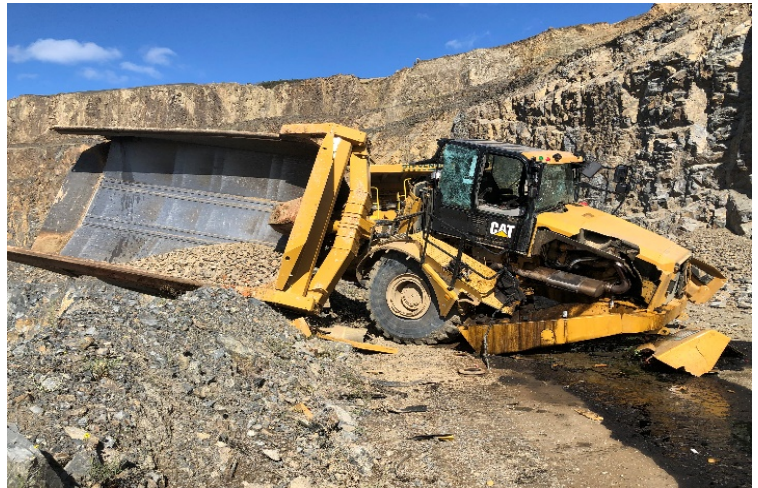
An ADT dump truck operating in a quarry left the haul road and fell approximately 12 metres landing on the quarry bench below, fatally injuring the driver.

1. All workers are trained and competent to operate machinery prior to use with follow up assessments to ensure knowledge is gained and understood.
2. Equipment is operated in accordance with Original Equipment Manufacturer (OEM) requirements.
3. Appropriate edge protection is installed on all haul roads in accordance with WorkSafe's [Health and Safety at Opencast Mines, Alluvial Mines and Quarries, November 2015, Good Practice Guidelines](#)
4. Regular workplace inspections are conducted to identify areas where edge protection is inadequate, and other activities that could put workers at risk of harm.
